Technical Bulletin

Service Plus Group: 09 -15 -0608

Subject: Fixing Poor Performing Air Conditioning System

Model: 2001-2004 Sequoia
2000-2004 Tundra

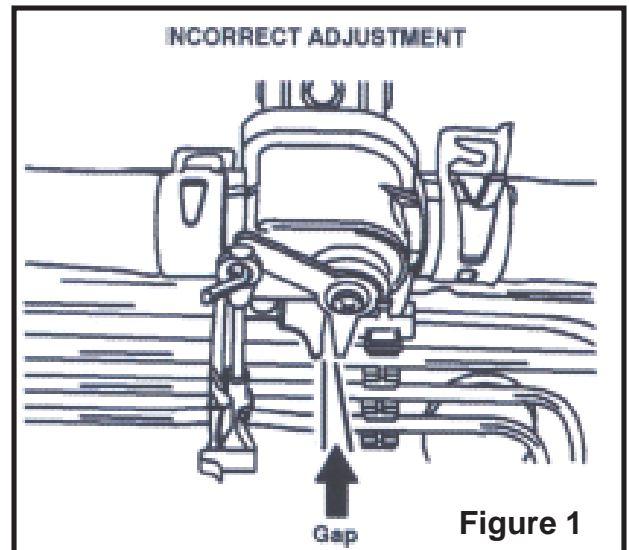
Figure 1

Complaint: Air conditioning system does not sufficiently cool the cabin especially when ambient temperatures exceed 80° F (26.6° C).

1. Turn the temperature control knob to the full cold position.
2. Inspect the clearance between the water control valve lever and the lever stop **(See Figure 1)**. If the lever does contact the lever stop, proceed with performance-testing the air conditioning system. If the lever does not contact the lever stop, proceed to step 3.
3. If the lever does not contact the lever stop:
 - A. Disengage the cable retaining clip.
 - B. Pull up on the cable sheath until the water control.
 - C. Re-fasten the cable retaining clip.
4. Cycle the temperature control knob several times and confirm proper water control valve adjustment **(See Figure 2)**.
