TOTAL CAR CARE SERVICES

TECHNICAL SERVICE BULLETINS

Subject: Engine Stall or Stumble

Model: 2011 - 2014 Cruze

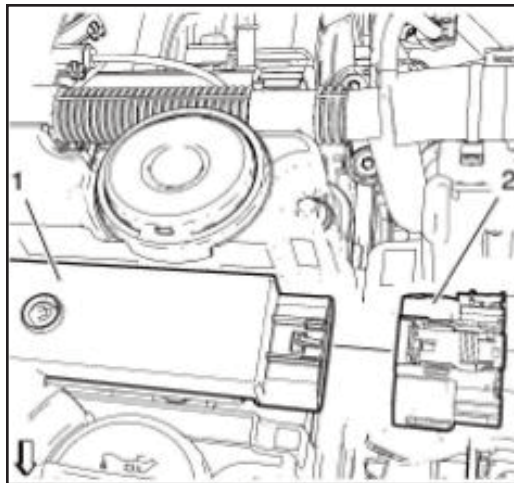
Cause: The ignition coil connector may have fretting on the terminals, causing a poor connection.

(1) Ignition coil and
(2) 7-pin ignition coil wiring harness connector

Action: Inspect the 7-pin coil pack connector for poor terminal contact or fretting. Replace connector with part number 19300958 if needed.
