TECHNICAL SERVICE BULLETINS

Manufacturer: Mazda (Bulletin# 01-014/14)

Subject: Check Engine Light On with Diagnostic Trouble Code P0456

Model: 2007-2014 CX-9
2011-2013 Mazda3

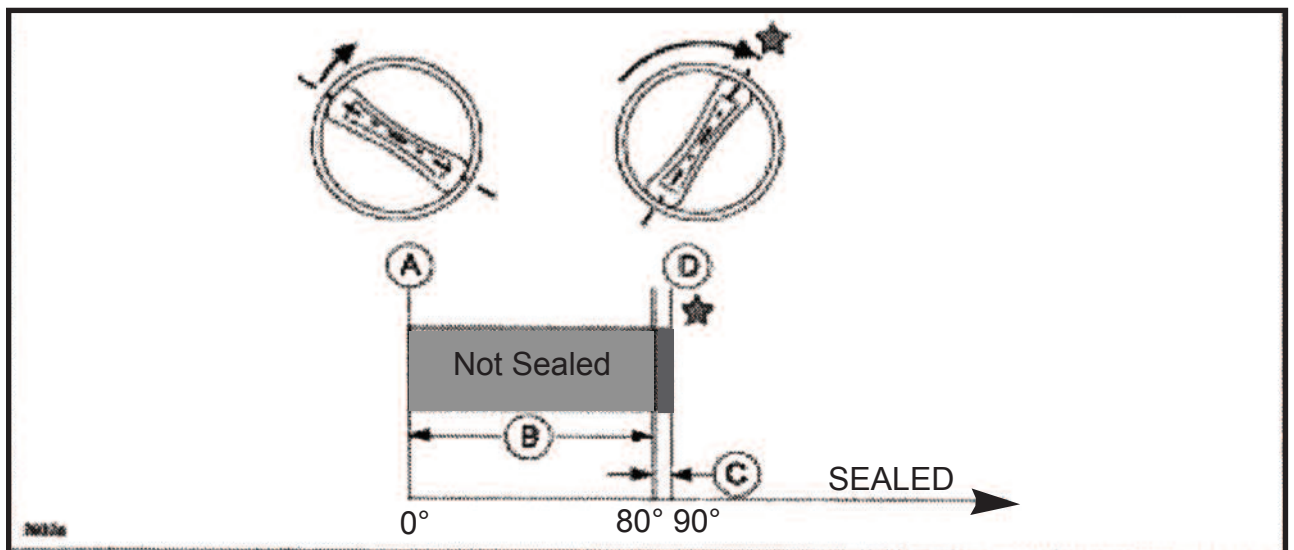
2011-2013 Mazda3, 2007-14 CX-9:

The concern is most likely the result of the customer not getting the fuel cap completely closed after fueling the vehicle. This causes a small fuel vapor to leak and turns DTC P0456 on.

- DO NOT replace any parts without detecting a leak,
- Explain to the customer that the fuel cap must be turned at least 80 degrees (C) or until two (2) or more click sounds are heard (D) to be properly sealed.
- If the fuel cap is not completely closed, it may stay in the B range (because the C range is so small) and will likely leak.

1. Verify the customer concern (and that DTC P0456 is stored in the PCM memory.)
2. Perform the diagnosis procedure for DTC P0456, refer to ALLDATA/ DirecTechPRO.
 - If a leak is detected, repair it according to the instructions in ALL-DATA/ DirecTechPRO
 - If no leak is detected, the most probable cause is the fuel cap was not completely seated (See figure 1)

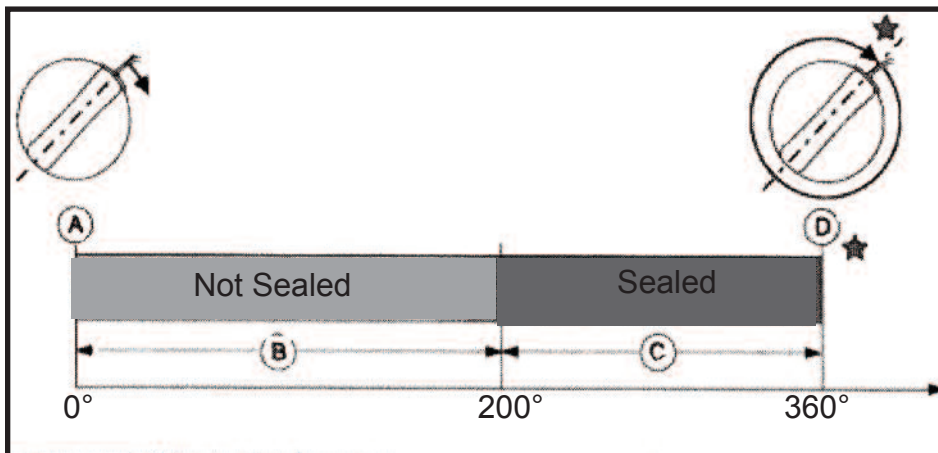
2014-2015 Mazda3, 2013-15-14 CX-5, 2014-2015 Mazda6:

- If the fuel cap is turned less than 200 degrees (B), it is not sealed.
- If the fuel cap is turned between 200-360 degrees (C), it is sealed.
- If the fuel cap is turned 360 degrees or more, it is sealed and a clicking noise (D) is also heard.

The fuel cap may stay within the (C) range, since it is a large range. A leak is unlikely to occur, even if the fuel cap was not closed completely (until clicking sound is heard (D)).
