Total Car Care Technical Service Bulletins

Manufacturer: Mazda (TSB-01-026/11)

Subject: Engine Rough Idle and MIL On with DTC P0351, P0352, P0353, P0354, P0355, P0356

Model: 2007-2009 CX-9 with VINs lower than JM3TB****8*164257 (produced before July 1, 2009)

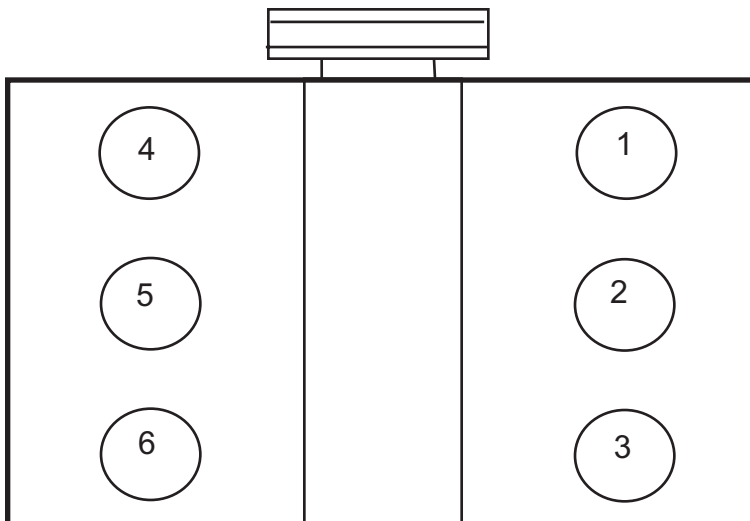
Issue: Some vehicles may experience a rough idle and MIL illumination with one or more of DTC's P0351, P0352, P0353, P0354, P0355, P0356 stored in the Powertrain Control Module (PCM) memory. In some cases, ignition coil (IC) damage may be found.

DTC	Description	Note
P0351	Ignition Coil No.1 primary/secondary circuit	RH (right hand)
P0352	Ignition Coil No. 2 primary/secondary circuit	
P0353	Ignition Coil No. 3 primary/secondary circuit	
P0354	Ignition Coil No. 4 primary/secondary circuit	LH (left hand)
P0355	Ignition Coil No. 5 primary/secondary circuit	
P0356	Ignition Coil No. 6 primary/secondary circuit

1. Verify customer concern.
2. Check the ignition coil circuit integrity for the concerned cylinder.
Refer to DirecTechPRO/ALLDATA.
 - Ignition coil connector or terminal malfunction.
 - PCM connector or terminal malfunction.
 - Open circuit between ignition coil terminal and PCM terminal.
 - Short to power supply between ignition coil terminal and PCM terminal.
3. If no trouble is found on the items shown above, replace the PCM and the ignition coil(s) related to the stored DTC. Refer to DirecTechPRO/ALLDATA.
4. Verify Repair.
