TECHNICAL SERVICE BULLETINS

Manufacturer: Mazda

Subject: Unstable Idling/Engine stalls just after stopping

Model: 2003-2009 Mazda 6 with 2.3L/2.5L (including Mazda speed 6); 2004-2009 Mazda 3 (including Mazda speed 3); 2006-2009 Mazda 5; 2006-2009 Mazda MX-5; 2007-2009 Mazda CX-7

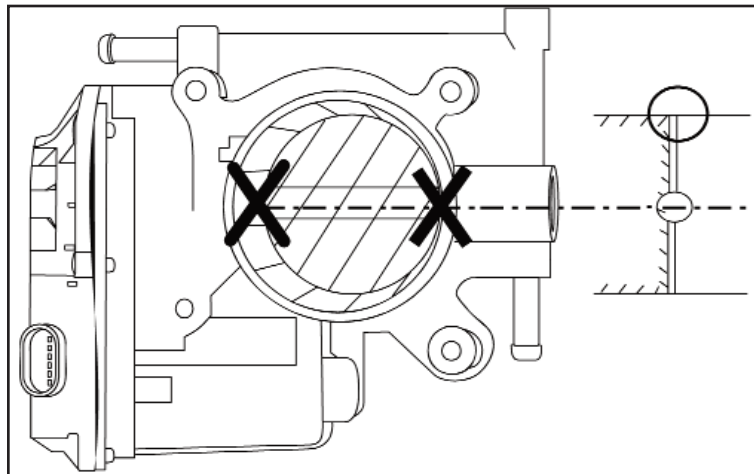
DO NOT SPRAY THE CLEANER DIRECTLY INSIDE THE THROTTLE BODY AND **DO NOT** WIPE AROUND THE THROTTLE VALVE SHAFT SHOWN WITH AN X.

- Solution:**
1. Verify customer concern.
 2. Remove the throttle body.
 - a. Write down the customer's radio station presets
 - b. Disconnect the battery terminals
 - c. Remove the air hose from the throttle body
 - d. Disconnect the throttle body connector
 - e. Remove the throttle body from the intake manifold with the water hose connected
 3. Clean the throttle body.
 - a. Clean the inside throttle body on the air hose side using a clean and soft shop cloth sprayed with engine cleaner along the cross hatch areas, and especially around the circled areas as shown
