## TECHNICAL SERVICE BULLETINS

**Manufacturer:** Mazda

**TCC Group:** 07 -39 -0915

**Subject:** Unstable Idling/Engine stalls just after stopping

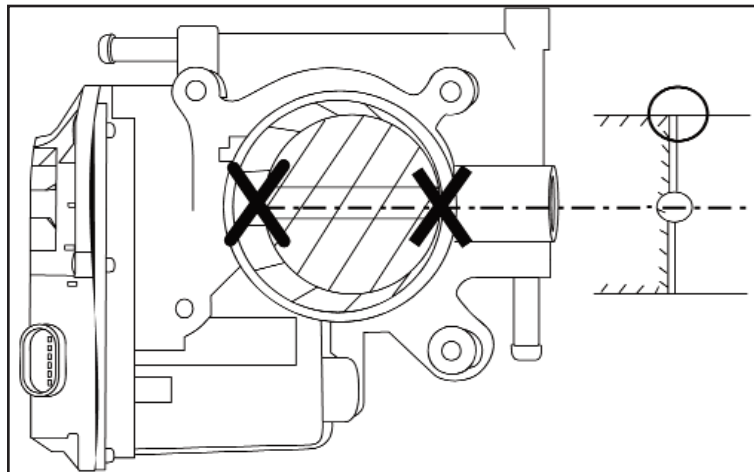
**DO NOT** SPRAY THE CLEANER DIRECTLY INSIDE THE THROTTLE BODY AND **DO NOT** WIPE AROUND THE THROTTLE VALVE SHAFT SHOWN WITH AN X.

- Solution:**
1. Verify customer concern.
  2. Remove the throttle body.
    - a. Write down the customer's radio station presets
    - b. Disconnect the battery terminals
    - c. Remove the air hose from the throttle body
    - d. Disconnect the throttle body connector
    - e. Remove the throttle body from the intake manifold with the water hose connected
  3. Clean the throttle body.
    - a. Clean the inside throttle body on the air hose side using a clean and soft shop cloth sprayed with engine cleaner along the cross hatch areas, and especially around the circled areas as shown

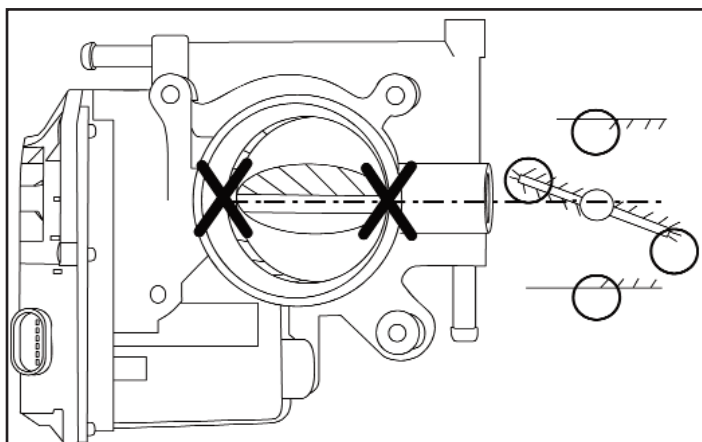
**DO NOT** SPRAY THE CLEANER DIRECTLY INSIDE THE THROTTLE BODY AND **DO NOT** WIPE AROUND THE THROTTLE VALVE SHAFT SHOWN WITH AN X.

- b. Turn the throttle body to clean it at the intake manifold side.
- c. Clean the throttle with the throttle valve opened using the same shop cloth and cleaner.
