Technical Bulletin

Service Plus Group: 08-06-0209

Subject: No Start 2.3L After Broken Timing Belt

Models: Ford/Mazda 2.3L OHC Engine

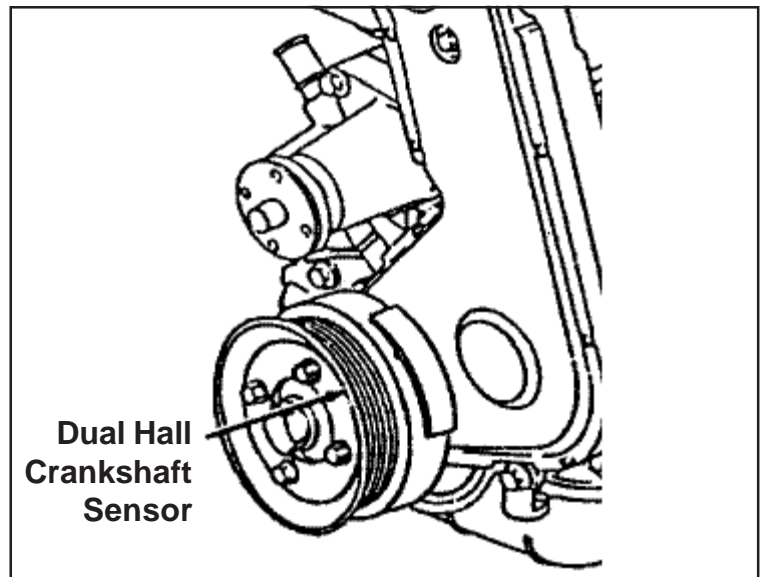
Dual Vane Actuator

Mounted on the harmonic balancer is a reluctor wheel. This reluctor is used to trigger the ignition module. It is possible that the reluctor wheel is no longer aligned properly. To check alignment, the dot on the reluctor must align with the keyway slot. If it is not, you may need to replace the harmonic balancer. It may also be possible to remove and re-align the reluctor to its proper position.
