GM
4L60/65/70E
Servicing Harsh Shift

File: GM
Date: February 2015

Servicing a Harsh GM Shift

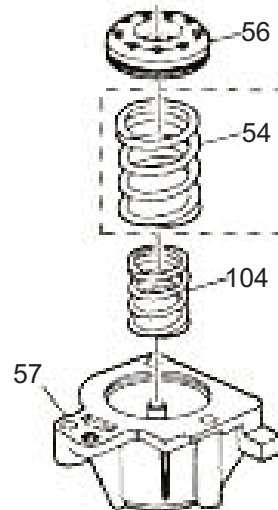
CAUSE: When inspecting the 1-2 accumulator assembly while diagnosing a condition of "Harsh 1-2 Shift," it is important to note that all transmission models use an inner spring (104), but many models do not use an outer spring (54).

Some GM transmission 1-2 accumulator assemblies feature both an inner and outer spring, while others feature only an inner spring. Adding an outer spring to an accumulator that was designed with only an inner spring can cause harsh 1-2 shifts.

NOTE DO NOT INSTALL AN OUTER SPRING (54) IN A TRANSMISSION BUILT WITH ONLY AN INNER SPRING (104). ADDING THE OUTER SPRING MAY CAUSE ADDITIONAL HARSH 1-2 SHIFTS AND/OR DELAYED 2-1 DOWNSHIFTS.
