TECHNICAL SERVICE BULLETINS

Manufacturer: Volkswagen (TB# 01 13 33)

Subject: MIL "ON" Diagnostic Trouble Code P0401

Model: 2009 Jetta, Jetta Wagon 2.0L TDI
2010-2013 Golf 2.0L TDI
2010-2014 Jetta Sedan, Jetta SportsWagen, Golf Wagen 2.0L TDI
2013-2014 Beetle, Beetle Convertible 2.0L TDI

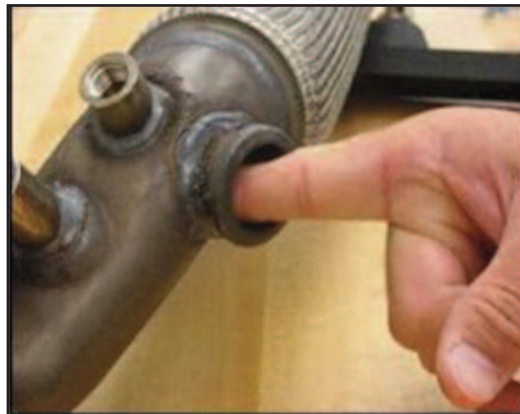
Figure 1

Service: When diagnosing a vehicle with the fault P0401 perform the following: Remove the EGR (Exhaust Gas Recirculation) filter from the DPF and swipe the inside of the exhaust pipe at the EGR filter connection point using a clean cloth or your finger. *See Figures 1 and 2.*

If your finger or the cloth comes out with black soot, replace the DPF & EGR filter together. If there is no soot on your finger, continue with diagnostics, this bulletin does not apply.
