No Turbine Sensor Signal

Jim Bartkus, from the AAMCO center in **New Rochelle NY**, sent in this tech tip on a 4R70W that will prevent a no turbine sensor signal.

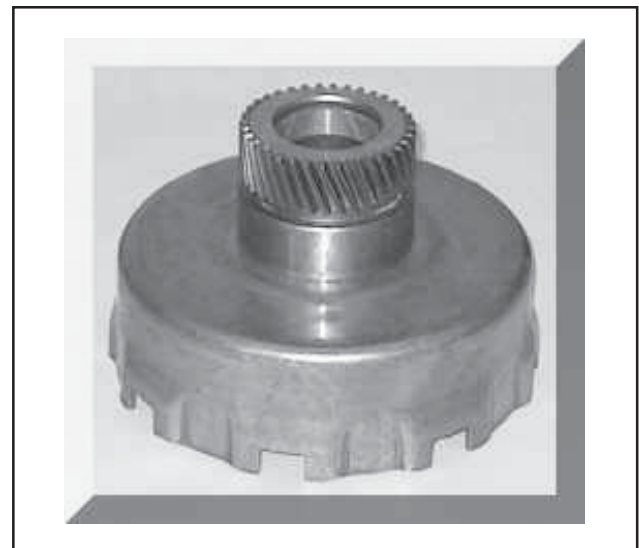
Sun Shell

Jim cautions when replacing the sun shell on a 2004 and up 4R70W/4R75W that has a turbine speed sensor, be sure that you replace the sun shell with one that is made of a non-ferrous metal. The turbine speed sensor needs to read the forward clutch drum inside the sun shell. If you use a sun shell that is made of a ferrous metal you will confuse the turbine sensor and it will not get the proper reading from the drum inside the shell. The result will be a code for no turbine speed signal.

NOTE In 2004, the sun shell has rivets at the bottom of the shell. In 2005 the rivets are eliminated so the non-ferrous sun shell looks just like the pre-2004 sun shell. The 2005 non-ferrous sun shell will retro fit to 2004.

To see if your sun shell is made on a non-ferrous metal, simply place a magnet against it to see if it will stick to it.
