ALLISON 1000 P0731 to P0735 gear ratio errors

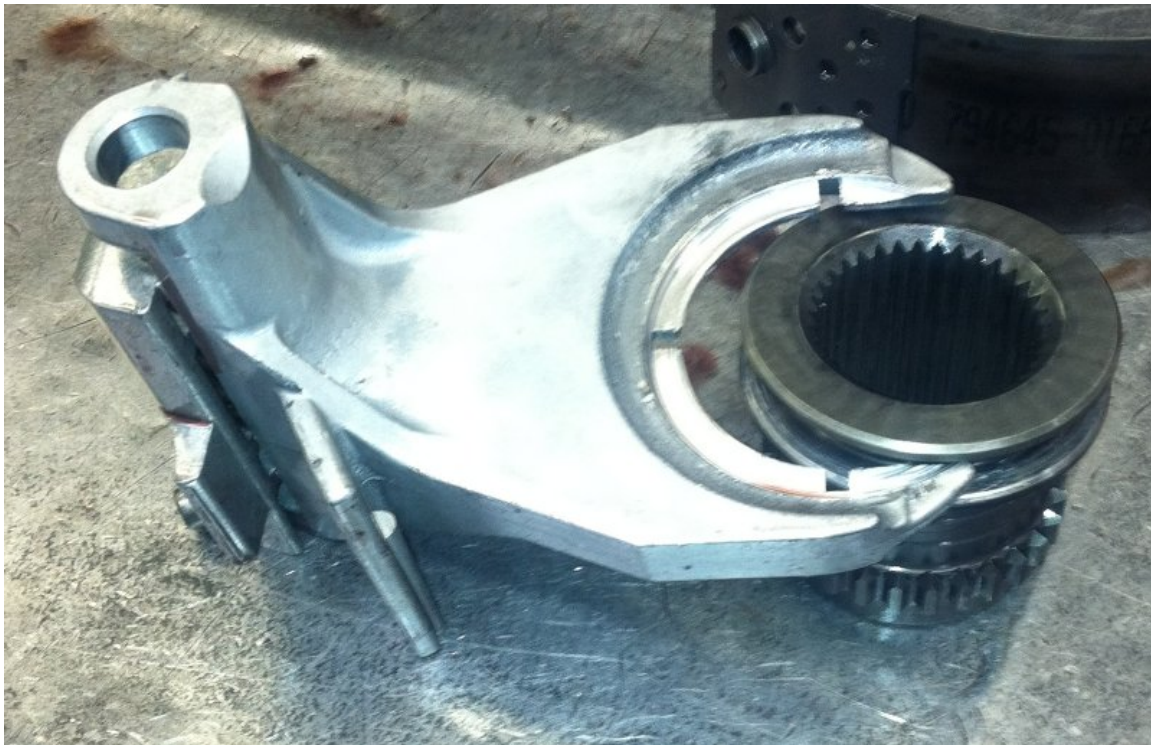
What’s happening here is the transfer case is jumping out of gear. The high / low range fork has worn out which lets the unit jump out of gear. You may hear a grind noise if you listen close when it neutrals.

To verify the problem take a snapshot with your scanner when the problem occurs. Look at the turbine sensor RPM before the code sets. If you see a 1000 – 1500 RPM increase check the transfer case first. Roll down the window, do you hear a grind during the flair? If so the transfer case needs repair. Take a look at the fork pictured below:
