# SERVICE PLUS TECHNICAL BULLETIN

**Service Plus Group:** 09-06-0605

**Subject:** Air Conditioning is Not Cold Enough (Replace Condenser)

**Model:** 2002 Buick Rendezvous  
2001-2002 Chevrolet Venture  
2001-2002 Oldsmobile Silhouette  
2001-2002 Pontiac Aztek, Montana

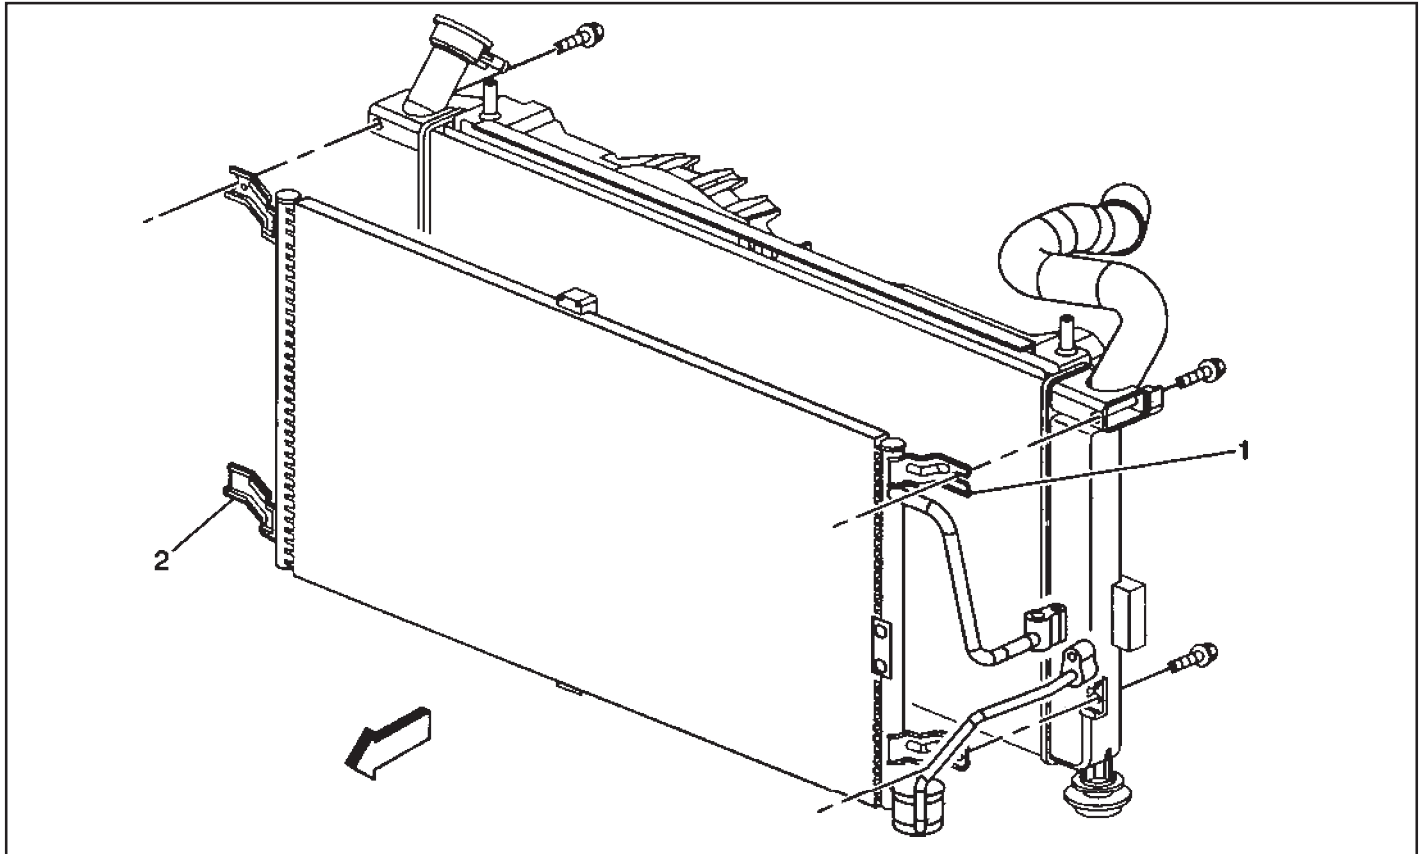
Some customers may comment that the HVAC (Heating, Ventilation and Air Conditioning) system does not get cold enough. You may find that the condenser is cracked and leaking at the lower right attachment bracket.

3. Refer to (1) and (2) in the illustration on the next page to find the locations where the condenser to radiator mounting will be changed.
4. At (2), (lower right attachment bracket), the new condenser will not have a hole in the bracket. Discard the bolt and J-nut that was used at this location with the original condenser.

5. At (1), (upper left attachment bracket), install a new J-nut, P/N 10335492, on the slotted condenser attachment bracket. Reuse the bolt that was in this location with the original condenser.
