TECH CALL P0957

Grand Caravan and Town & Country Vehicles with erratic shifts and trouble code P0957.

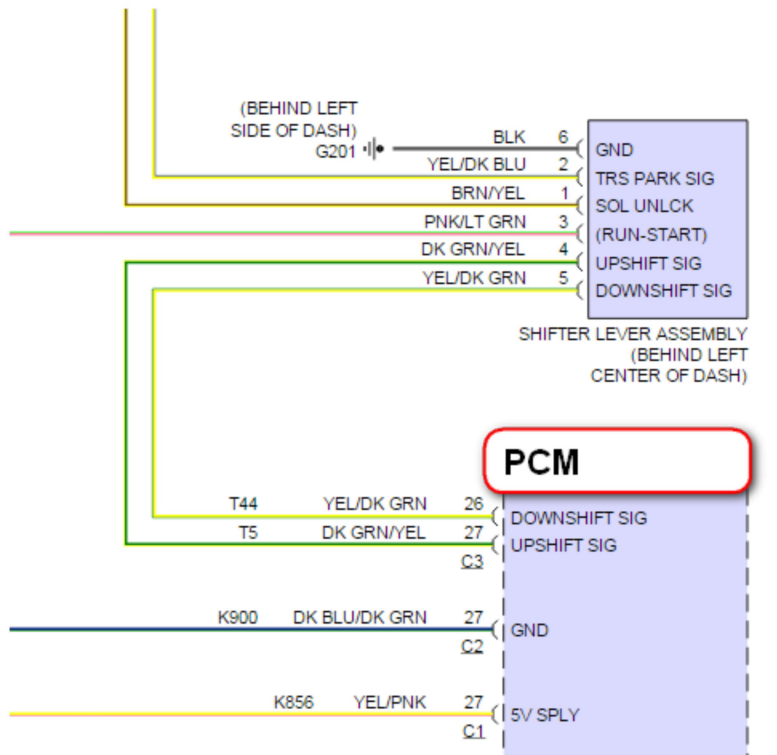
The AutoStick® switch contains two hall effect switches connected to ground. The PCM has two separate inputs, upshift and downshift. When the PCM detects an input from the switch, upshift or downshift, it will shift the transmission to the desired gear. If the PCM detects both inputs at the same time, the DTC will set.

Cut the Yellow/Dark Green wire at the shifter. This is the downshift input to the Powertrain Control Module (PCM) from the AutoStick® Shifter.

If the condition and code are still present, cut the Yellow/Dark Green wire at pin 26 in the C3 (White) connector of the PCM. If the problem is gone, the wire is shorting to ground.

The wire diagram below is a typical Dodge Caravan diagram however your vehicle may be different. Please check your wiring diagram in All Data before cutting any wires.

Test drive the vehicle to see if the condition and code are gone. If yes, repair the cut wire and replace the shifter.

Look for the short where the wire loom exits the console. If you can't locate the short, look under the hood at the wire loom. If you still can't find the short then run a new overlay wire from the PCM to the AutoStick® Shifter.
