Phantom Transfer Case Shifting with Code C1404

Dodge Trucks with the NV 233 Transfer Case

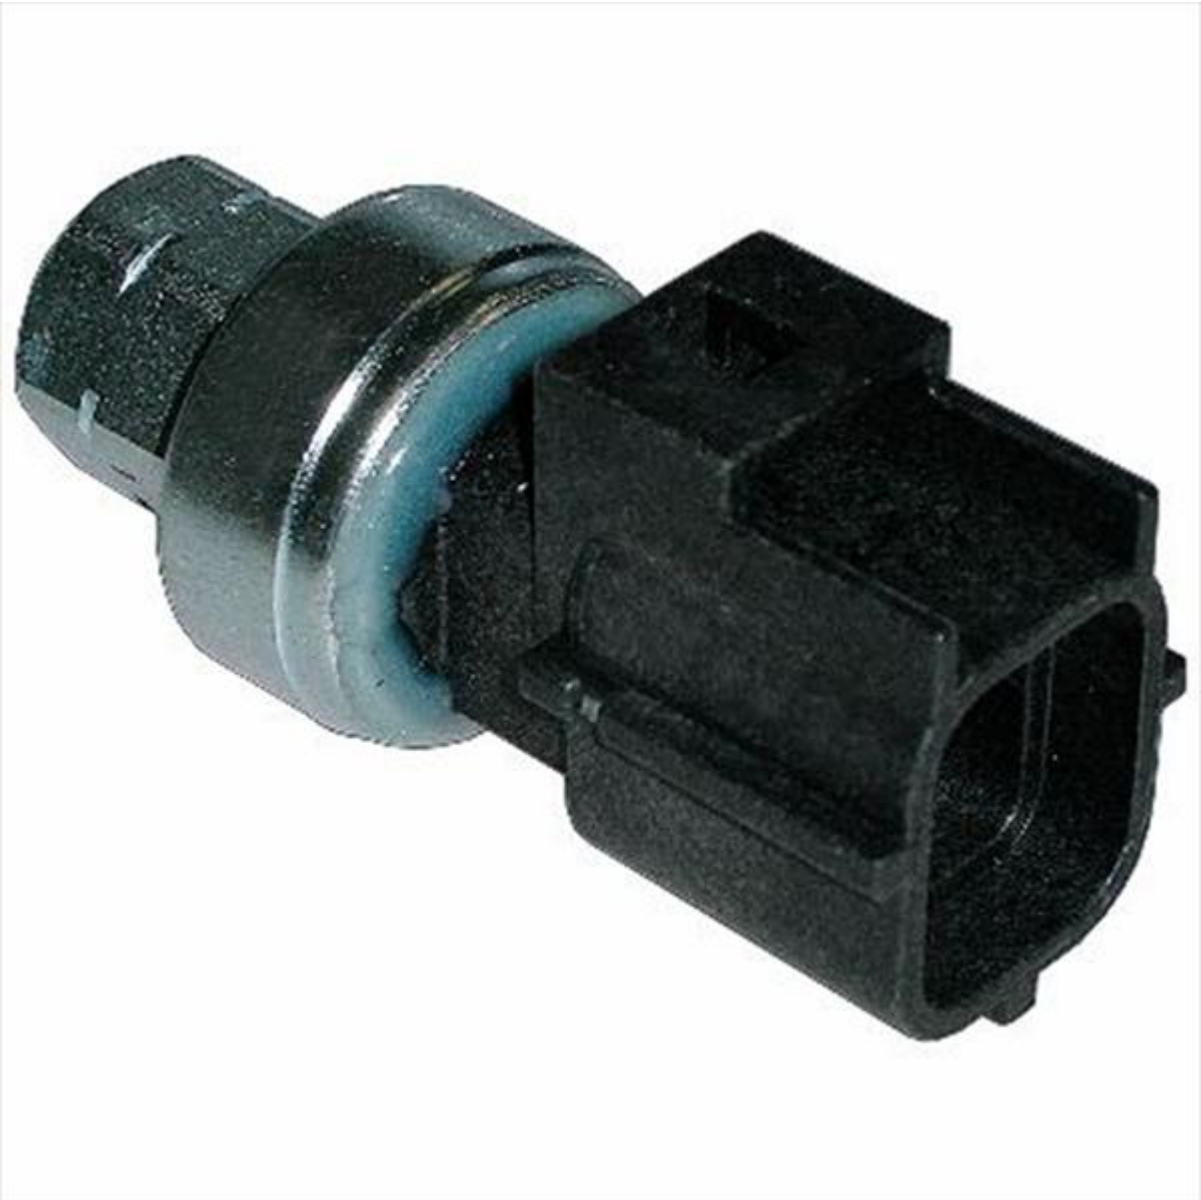
Typical A/C Transducer

The A/C pressure sensor can short out and cause this condition. Since this is an Intermittent problem, disconnect the pressure sensor as a test.

Drive the truck and confirm that the problem is gone. If so replace the A/C Pressure Sensor.
