## Erratic Reverse & Shifts

For your tip on ZF5HP19 Erratic Reverse & Shifts!

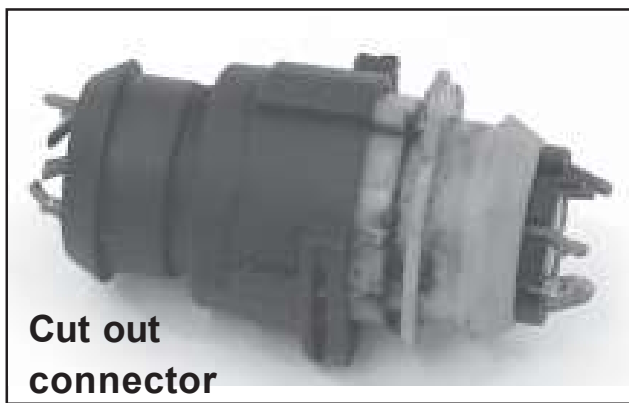
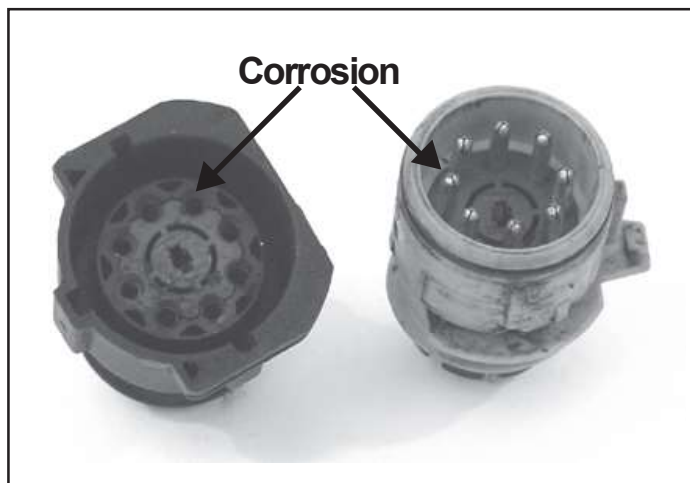
Neil Evans, from N. Hollywood, CA, shares his experience with 96-up Audi A4 and 97-up Audi A6 units. According to Neil, these units leak engine oil onto the connector for the MLPS. When this happens the rubber expands and gets soft like a vacuum hose with ATF in/on it. This causes water to be able to get into the connector, corrode the terminals and cause a loose of signal to ground.

Neil says he has seen 4 different cars where this has caused erratic reverse and shifts sometimes with a code and sometimes without.

Neil's fix is to cut out the connectors and eliminate them by soldering the wires together.
