Do These or CB's

Enclosed is a General List of tests, checks and basic things you should do as part of an EDS, Rebuilding, Inspection of a transmission or installing a fresh rebuild. Read them over, become familiar with them, if you're not already, and put them into practice.

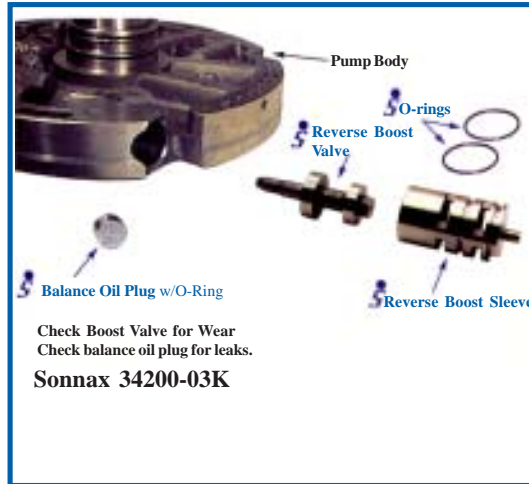
8.

Check Boost Valve for Wear
Check balance oil plug for leaks.
Sonnax 34200-03K

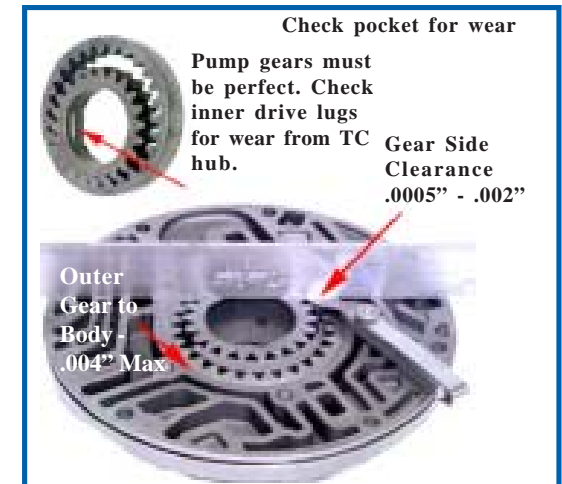
9.

Check pocket for wear
Pump gears must be perfect. Check inner drive lugs for wear from TC hub.

Outer Gear to Body - .004" Max

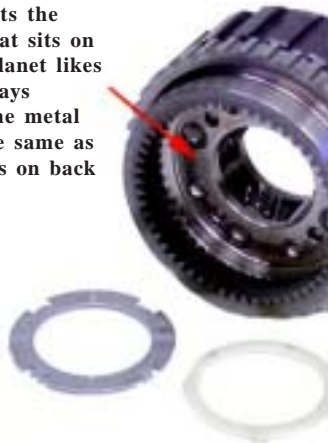
10.

Just like 400 units the plastic washer that sits on top of the rear planet likes to wear out. Always replace it with the metal style which is the same as the washer that is on back of output shaft.

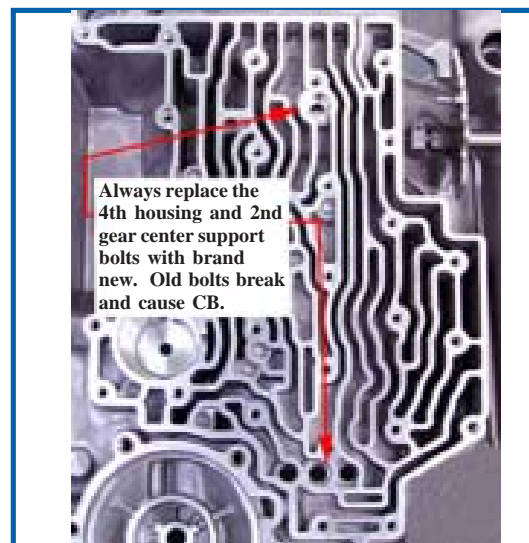
11.

Always replace the 4th housing and 2nd gear center support bolts with brand new. Old bolts break and cause CB.

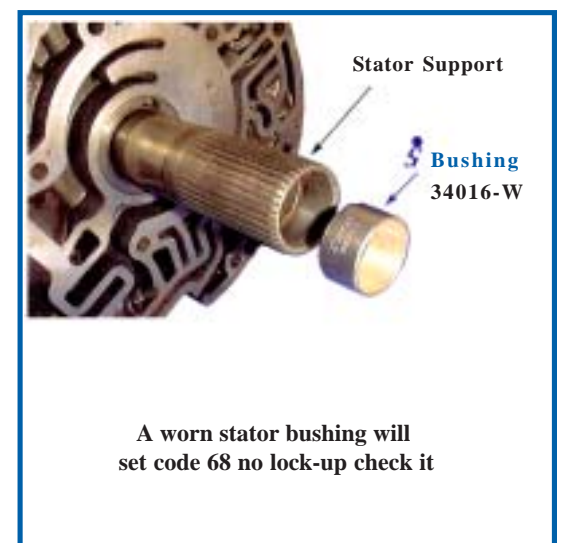
12.

A worn stator bushing will set code 68 no lock-up check it

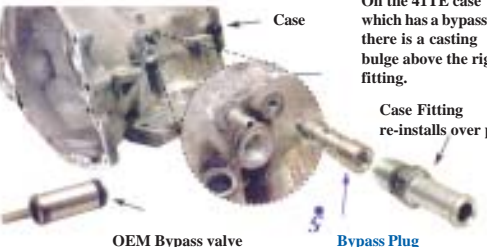
9.

On the 41TE case which has a bypass, there is a casting bulge above the right fitting.

Always install a new OEM Bypass valve or better install a Sonnax Bypass valve #92836-01K

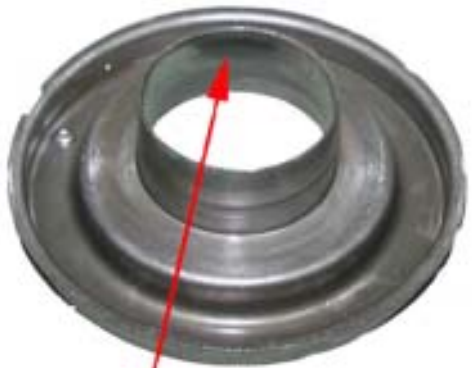
11.

Inspect inside bore of UD piston for wear and ridges. Worn bore causes leaks that produce delayed forward and other complaints.

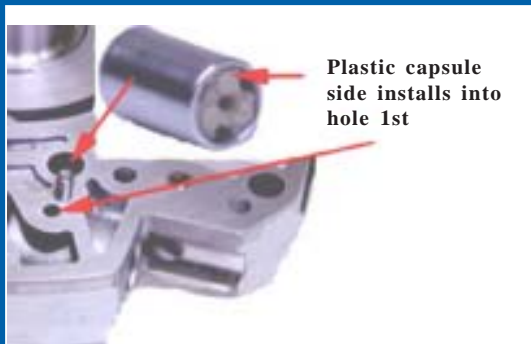
1.

Important
Plastic capsule likes to break up than moves down into TCC bore & locks valve solid.

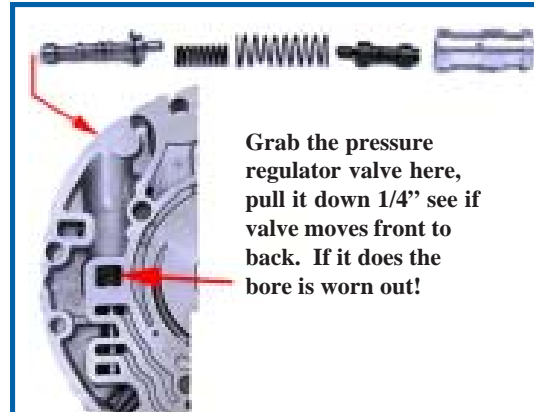
2.

Grab the pressure regulator valve here, pull it down 1/4" see if valve moves front to back. If it does the bore is worn out!

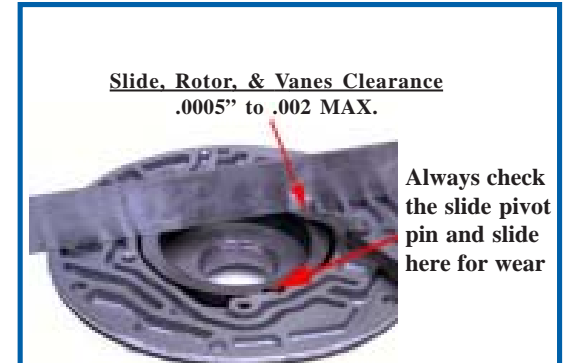
3.

Slide, Rotor, & Vanes Clearance
.0005" to .002 MAX.

Always check the slide pivot pin and slide here for wear

Important
Always check pump clearance. Rebuilds are usually TOO TIGHT or TOO LOOSE

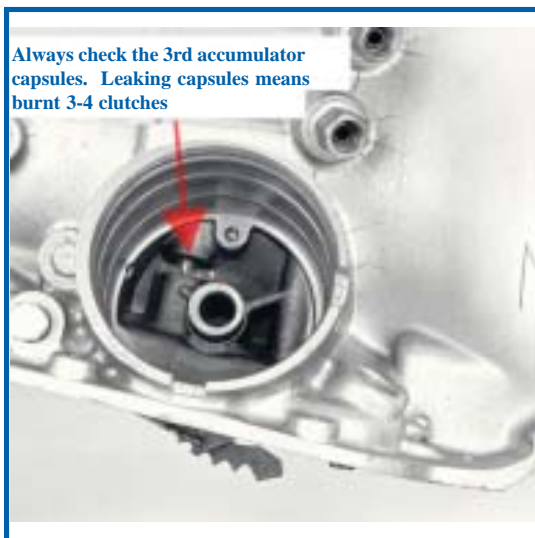
4.

Always check the 3rd accumulator capsules. Leaking capsules means burnt 3-4 clutches

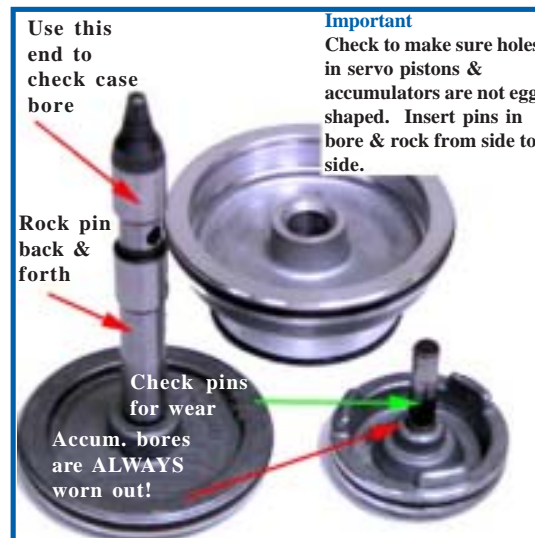
5.

Important
Check to make sure holes in servo pistons & accumulators are not egg shaped. Insert pins in bore & rock from side to side.

Accum. bores are ALWAYS worn out!

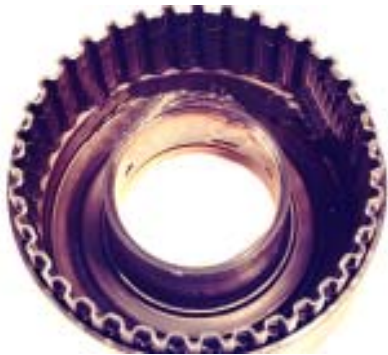
1.

Always check the weld for cracks, leaks.

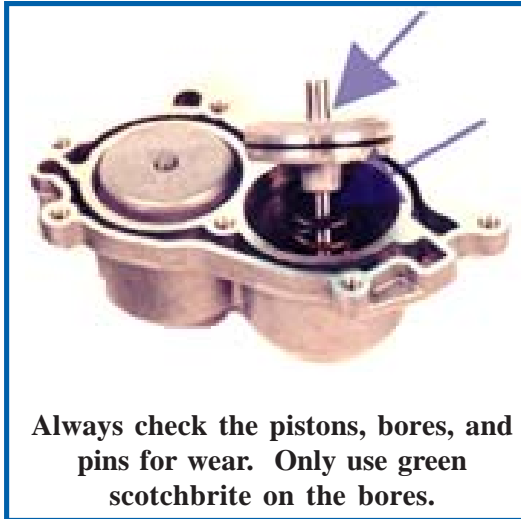
2.

Always check the pistons, bores, and pins for wear. Only use green scotchbrite on the bores.

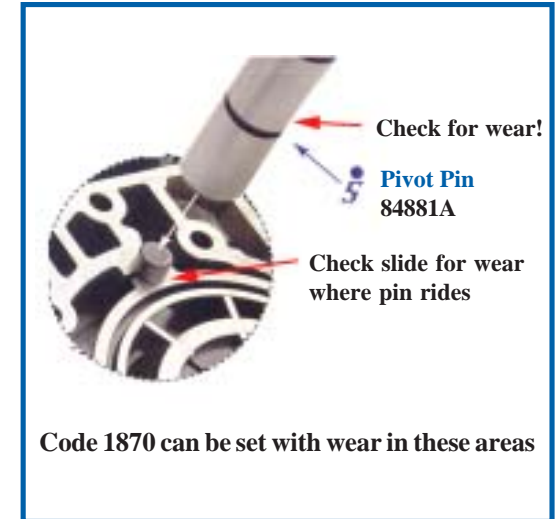
3.

Code 1870 can be set with wear in these areas

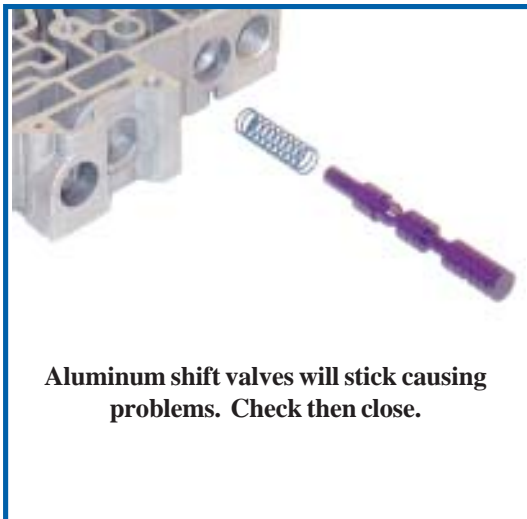
4.

Aluminum shift valves will stick causing problems. Check then close.

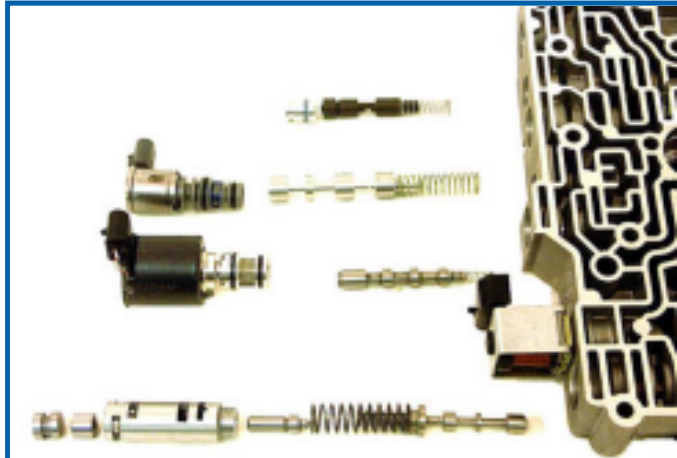
1. Check TCC regulated apply valve for wear. Always replace "O" Rings on end plug.
2. Check TCC apply valve for wear.
3. Always replace EPC solenoid. Bad Solenoid=Code P1811.
4. Use Correct TCC Solenoid not the same as 4L60-E. ID by purple paint daub.
5. Check pressure regulator boost valve and sleeve.

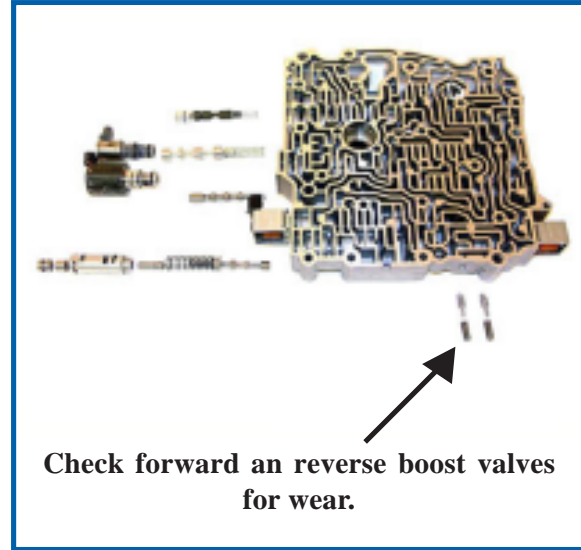
2.

Check forward an reverse boost valves for wear.

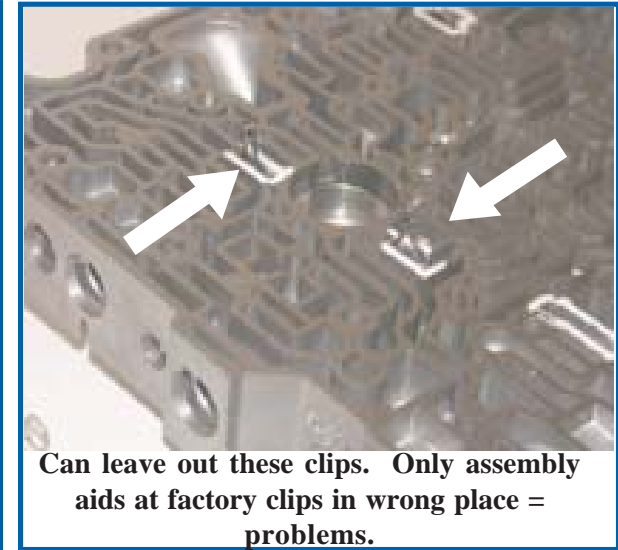
3.

Can leave out these clips. Only assembly aids at factory clips in wrong place = problems.

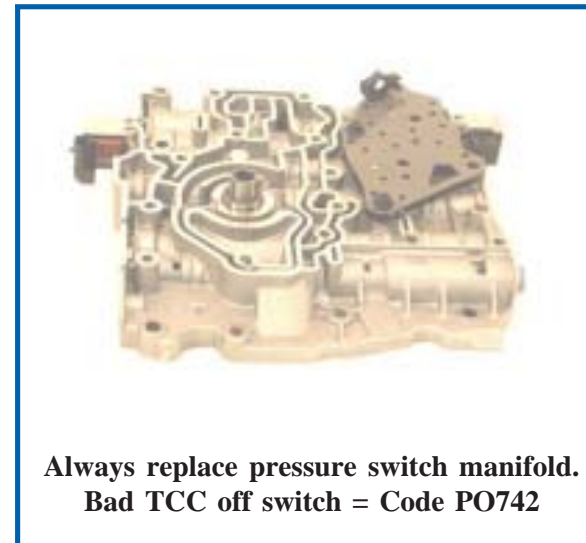
4.

Always replace pressure switch manifold.
Bad TCC off switch = Code PO742

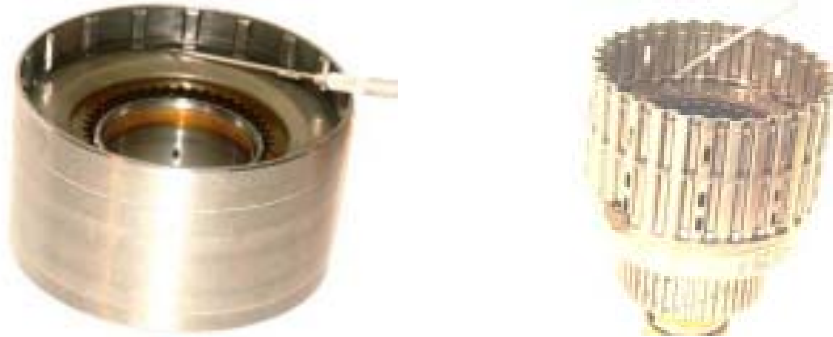
5.

Heavy duty applications set clutch clearance to .010 per friction or .005 per one sided friction. Alto Kit - #062757

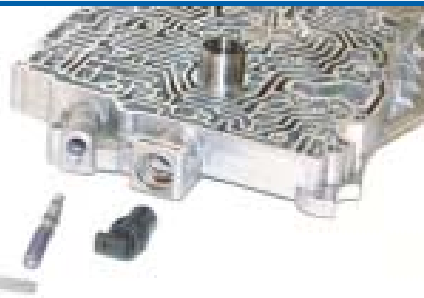
7.

Always check actuator feed limit valve for wear. Causes TCC Piston failure, High Line Pressure, Poor EPC Control and 2nd Gear Starts. Sonnax 84596-02K*

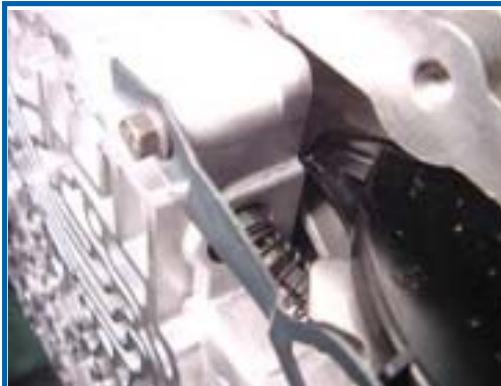
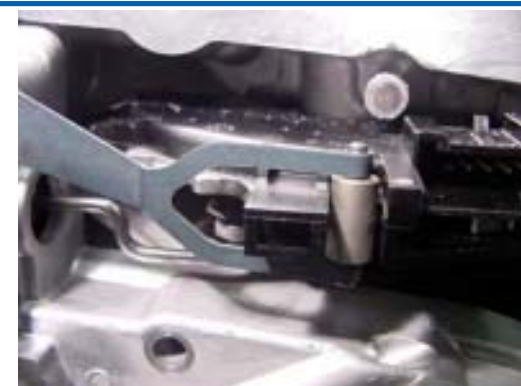
8.

Make sure internal mode switch is assembled properly

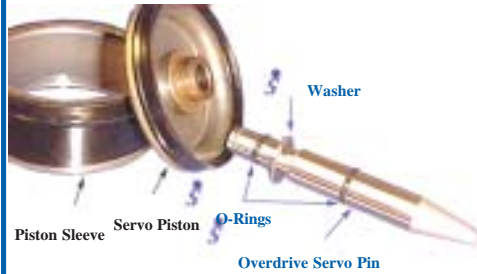
8.

Always check for pin to case wear.
Sonnax # 7833E
Always replace molded rubber, Servo cover and servo's.

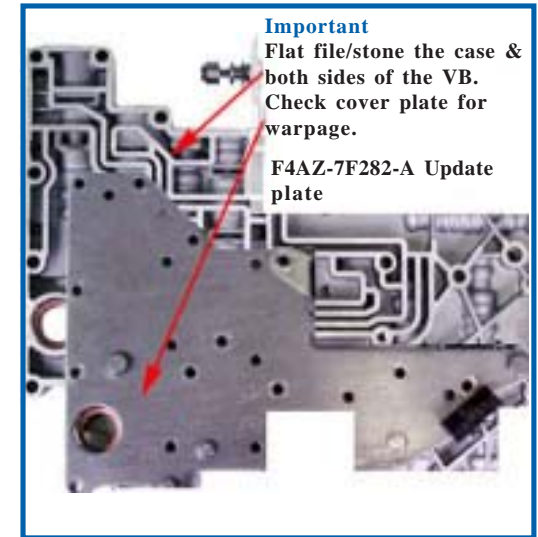
9.

Important
Flat file/stone the case & both sides of the VB. Check cover plate for warpage.
F4AZ-7F282-A Update plate

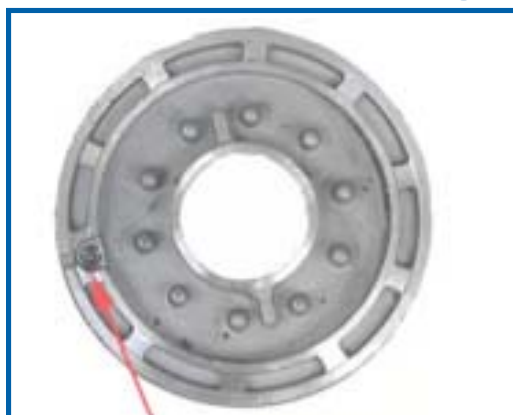
10.

Check ball in direct piston likes to leak and cause clutch to burn up. Reseat by tapping check ball down against seat with a punch and hammer.

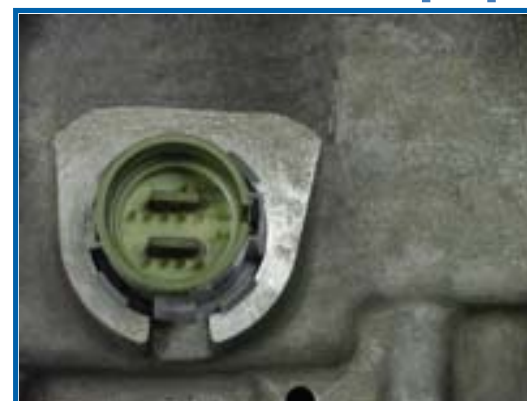
11.

If there is ATF present in "Any" case connectors replace the connectors or harness. ATF will cause shift problems. (4L60-E shown)

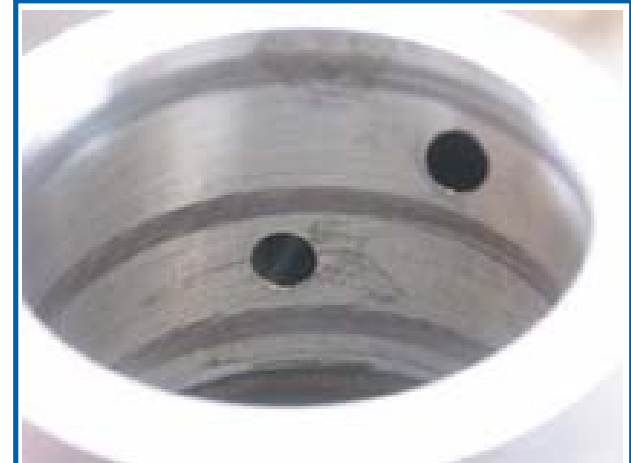
Check case for ring wear

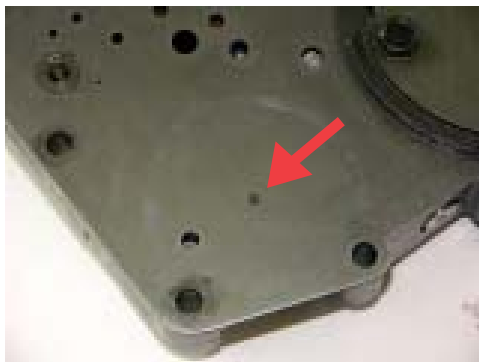
Look close in this area late style plates crack from direct clutch accumulator cover hitting.

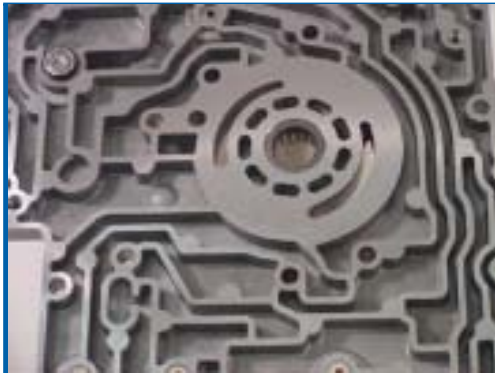
1.

Always install pump shaft seal toward V.B. for better bearing lube

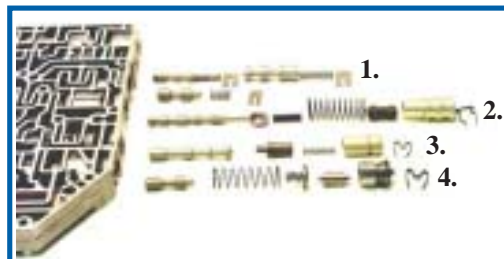
These Bores Wear, Check Them, Fix Them.

1. Solenoid regulator and converter regulator valves. Causes TCC Problems. Sonnax 96201-21K,* 96201-23K*
2. Pressure regulator boost valve and sleeve. Causes 1-2 & 2-3 Upshift Flare. Sonnax 96201-12K (3.0L), 96201-01K (3.8 & 4.6L)
3. Bypass clutch control valve, plunger and sleeve. Causes TCC Codes. Sonnax 96206-05K*
4. Line pressure modulator valve and sleeve (up to 97). Causes Soft 1-2 & 2-3 shifts. Sonnax 96948-01K

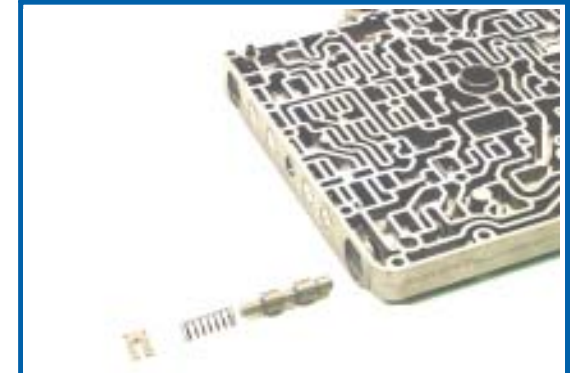
3.

Check Forward clutch control valve for sticking and broken retainer. Causes No Forward, No 4th. Sonnax 96206BST

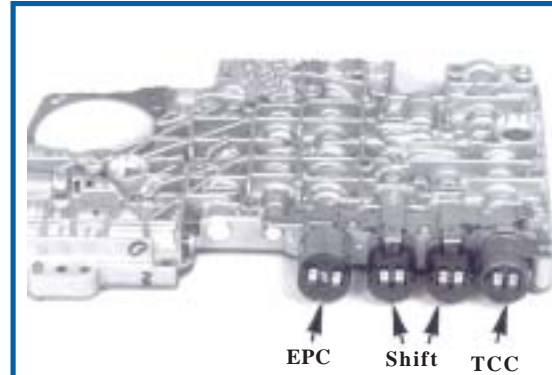
2.

There are many problems with the EPC's. Only use correct replacement.

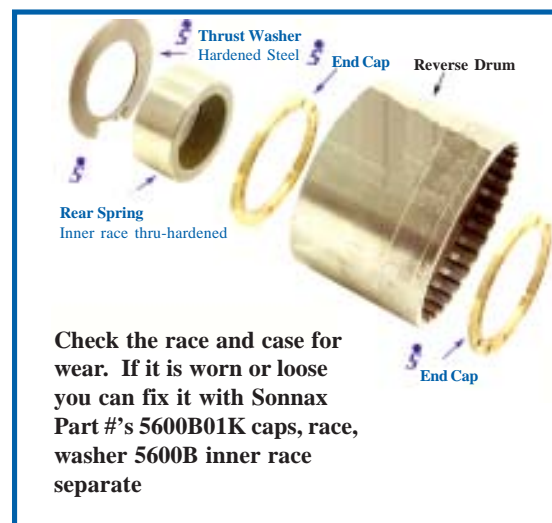
5.

Check the race and case for wear. If it is worn or loose you can fix it with Sonnax Part #'s 5600B01K caps, race, washer 5600B inner race separate

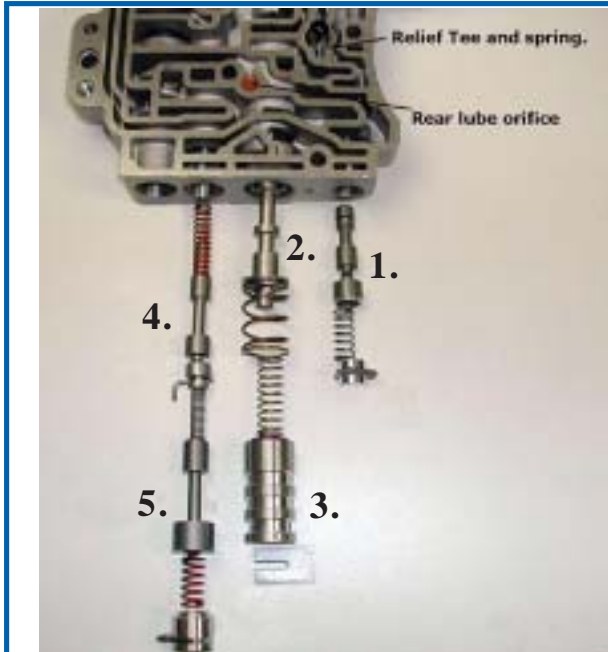
11.

These Bores Like to Wear. Check Them. Fix Them

1. Forward Engagement Control Valve - Causes Delayed Forward Engagement. 1 & 3 are in Sonnax Kit 37947-EZ
2. Worn Pressure Regulator - Causes Delayed Engagements, High or Low Line Pressure. Sonnax 37947-05K
3. Worn Pressure Boost Valve - Causes Soft Shifts, Delayed Reverse. Sonnax 37947-01K
4. Worn EPC Boost Valve and/or Loose Boost Valve Plug - Causes Poor Shift Quality, Delayed Forward or No Reverse.*
5. Worn Forward Modulator - Causes Poor Shift Quality, Delayed Forward or No Reverse. 4 & 5 are in Sonnax Kit 37947-11K*

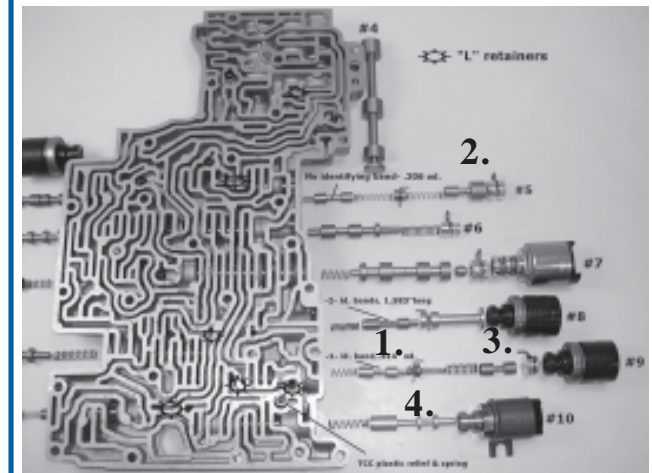
12.

These Bores Like to Wear. Check Them. Fix Them.

1. Worn Coast Clutch Shift Valve - Causes No 4th Gear 4R44, No 2nd and 5th Gear 5R55, Sonnax 37947-33K
2. Worn Reverse Modulation Valves - Causes Delay in Reverse. Sonnax 37947-11K*
3. Worn TCC Regulator Valve - Causes Converter Apply Issues, High TCC Slip RPM, TCC Slip Codes. Sonnax 37947-09K
4. Worn TCC Modulator Valve - Causes Converter Apply Issues, High TCC Slip RPM, TCC Slip Codes. Sonnax 37947-07K

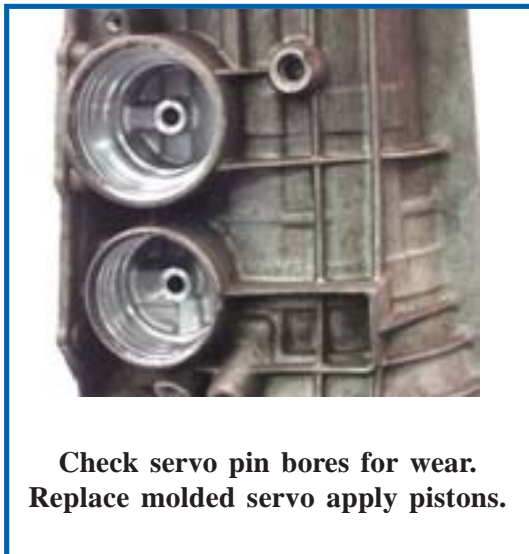
4.

Check servo pin bores for wear. Replace molded servo apply pistons.

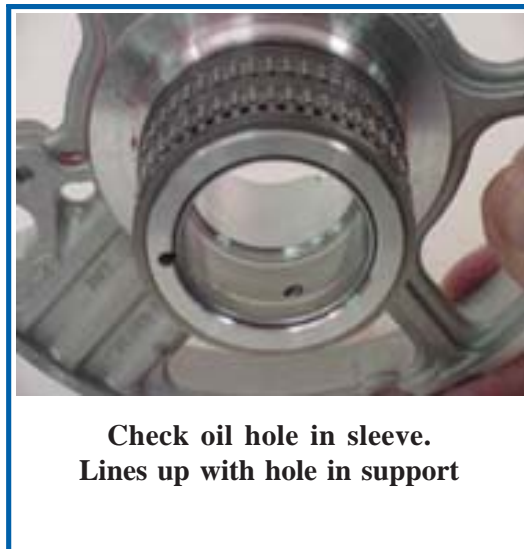
5.

Check oil hole in sleeve. Lines up with hole in support

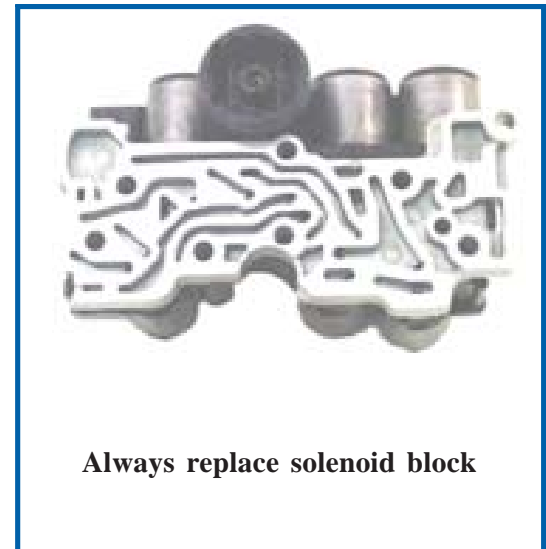
6.

Always replace solenoid block

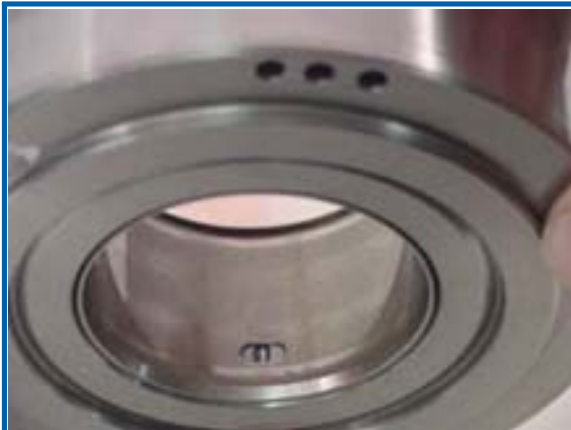
7.

Check oil hole in sleeve. Lines up with hole in drum.

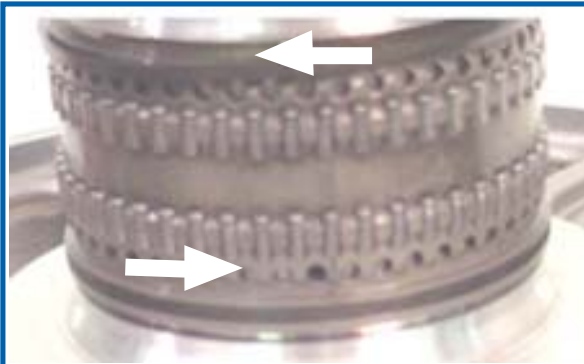
8.

Check oil hole in bearing lines up with hole in support. Check race for cracks.

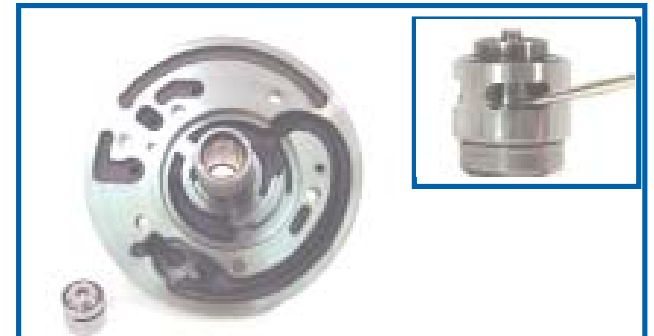
9.

Always replace flow control valve and o-rings.

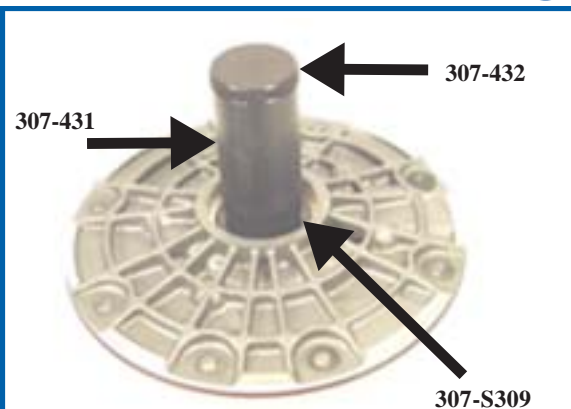
10.

Always use special tools to line-up pump

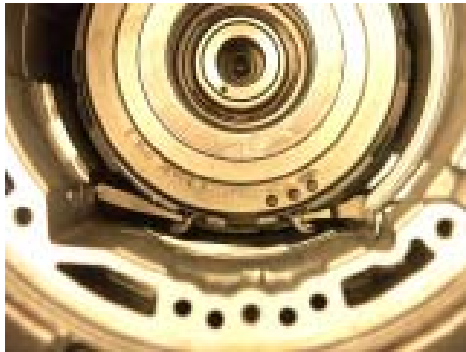
13.

Band struts are critical. If installed incorrectly, it will cause slips, missed shifts.

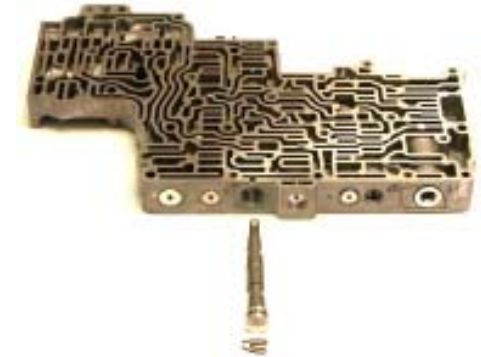
15.

Always check 4-3 prestroke valve spring. Frequently breaks - causes codes. Sonnax # 56947J-S1

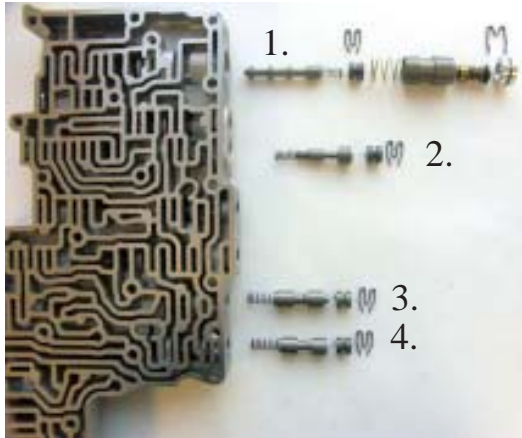
17.

These Bores Wear. Check Them. Fix Them.

1. Worn TCC Control Valve Bore - Causes Excessive TCC Slip, Code P0741, Overheated Converters, Restricted Cooler Flow. Sonnax 56947J-05K*
2. Worn VFS2 Modulator Valve Bore - Causes Solenoid Performance codes, Line Pressure Concerns, Slipping Upshifts. Sonnax 56947J-19K*
3. Worn Reverse Modulator Valve - Causes Delayed Reverse Engagement, Loss of 4th and 5th Gear, Burned Direct Clutch. Sonnax 56947J-23K*
4. Worn Reverse Engagement Valve - Causes Slipping or Loss of Reverse, Burned Direct Clutch, Delayed Reverse Engagement. Sonnax 56947J-29K*

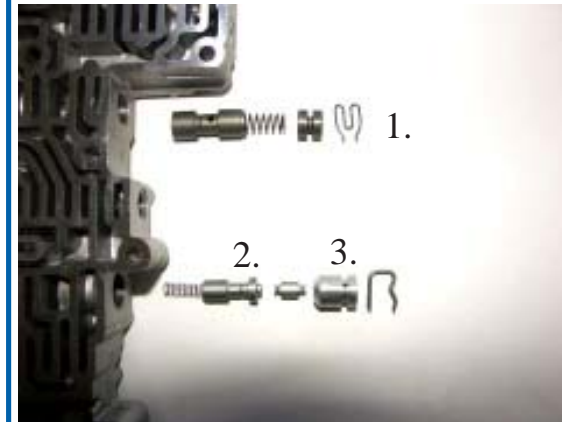
18.

These Bores Wear. Check Them. Fix Them.

1. Worn Forward Engagement Valve Bore - Causes Slipping or Loss of Forward Gears, Burned Forward Clutch, Delayed Forward Engagement. Sonnax 56947J-26K*
2. Worn TCC Modulator Valve Bore - Causes Excessive TCC Slippage, Codes P0741, P1783, Transmission Overheating, High Line Pressure. Sonnax 56947J-15K*
3. Worn TCC Modulator Sleeve and/or Plunger - Causes TCC Slip Codes, Transmission Overheating. Sonnax 56947J-01K

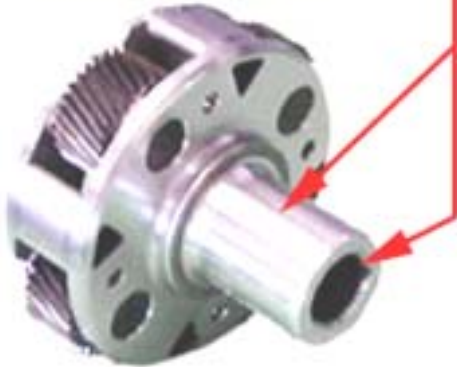
7.

Check hub for cracks and splines for stripping. If hub is cracked OD sprag is bad. If you install a bushing in the OD planet support, Machine planet neck .020 - .030"

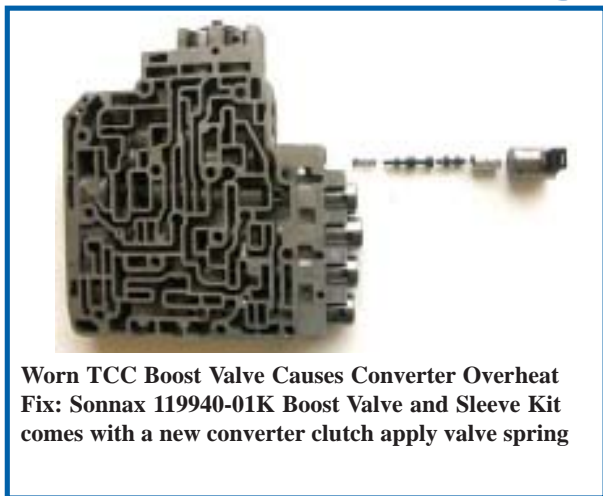
6.

Worn TCC Boost Valve Causes Converter Overheat
Fix: Sonnax 119940-01K Boost Valve and Sleeve Kit comes with a new converter clutch apply valve spring

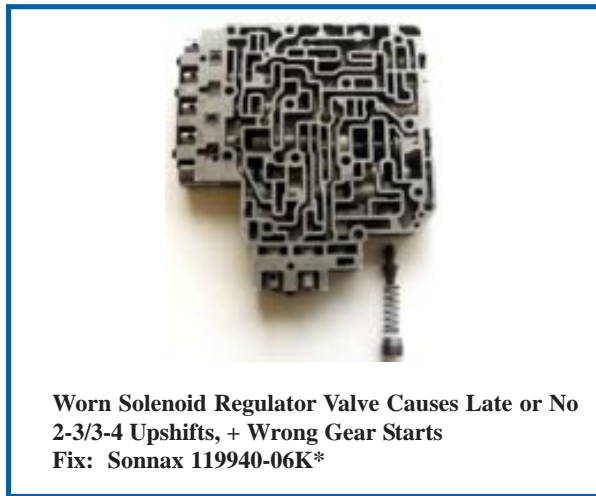
7.

Worn Solenoid Regulator Valve Causes Late or No 2-3/3-4 Upshifts, + Wrong Gear Starts
Fix: Sonnax 119940-06K*

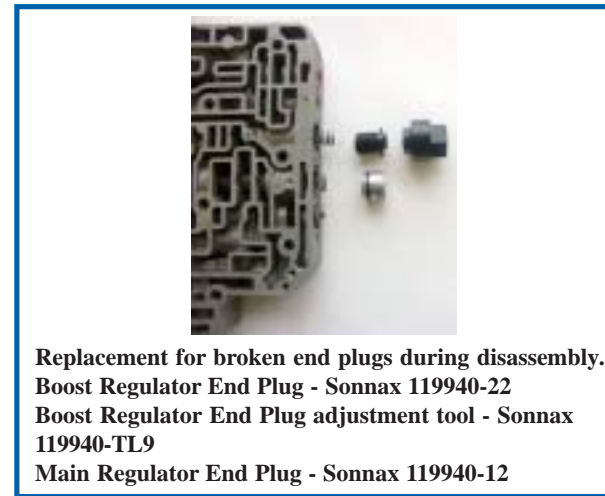
8.

Replacement for broken end plugs during disassembly.
Boost Regulator End Plug - Sonnax 119940-22
Boost Regulator End Plug adjustment tool - Sonnax 119940-TL9
Main Regulator End Plug - Sonnax 119940-12

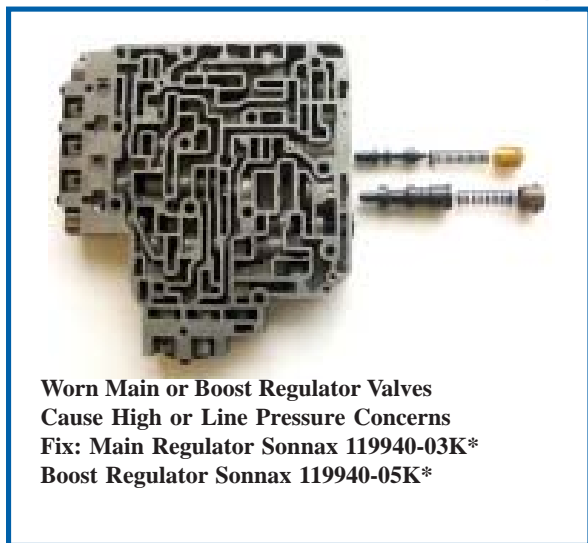
9.

Worn Main or Boost Regulator Valves Cause High or Line Pressure Concerns
Fix: Main Regulator Sonnax 119940-03K*
Boost Regulator Sonnax 119940-05K*

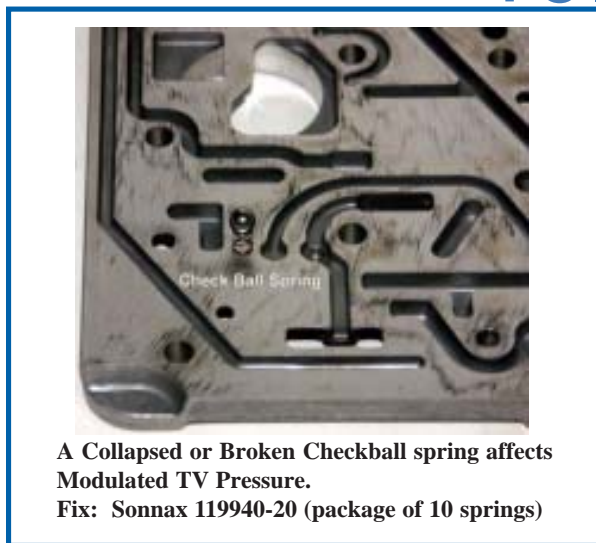
10.

A Collapsed or Broken Checkball spring affects Modulated TV Pressure.
Fix: Sonnax 119940-20 (package of 10 springs)

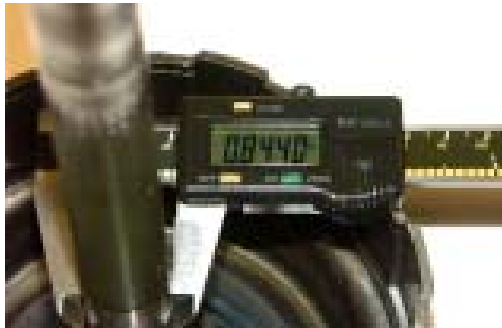
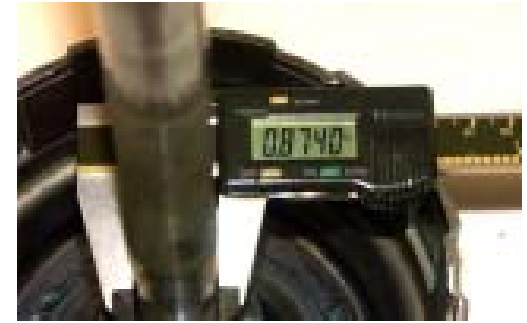
2.

If you are replacing the forward and direct clutch housing make sure you have the correct size input shaft
.844 or .874

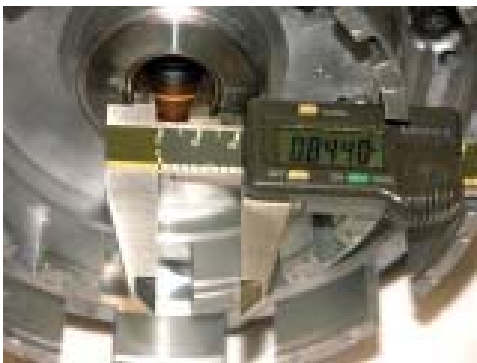
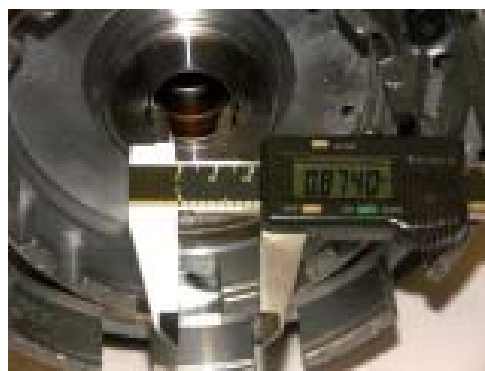
3.

If you are replacing the pump or stator make sure you have the correct replacement, .844 or .874

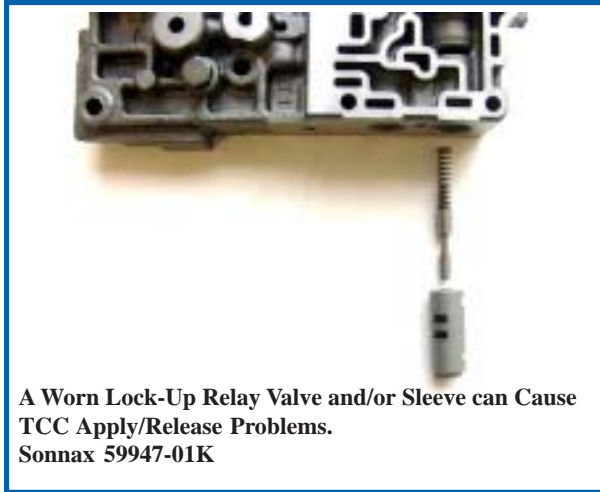
5.

A Worn Lock-Up Relay Valve and/or Sleeve can Cause TCC Apply/Release Problems. Sonnax 59947-01K

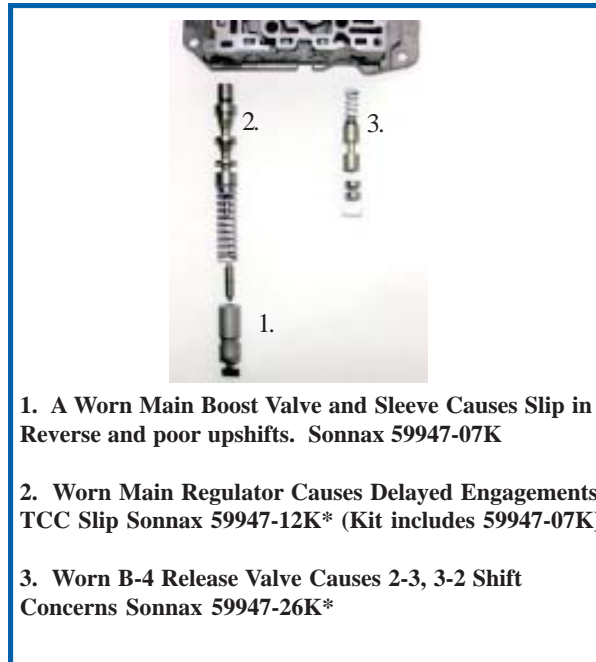
6.

- 1. A Worn Main Boost Valve and Sleeve Causes Slip in Reverse and poor upshifts. Sonnax 59947-07K
- 2. Worn Main Regulator Causes Delayed Engagements, TCC Slip Sonnax 59947-12K* (Kit includes 59947-07K)
- 3. Worn B-4 Release Valve Causes 2-3, 3-2 Shift Concerns Sonnax 59947-26K*

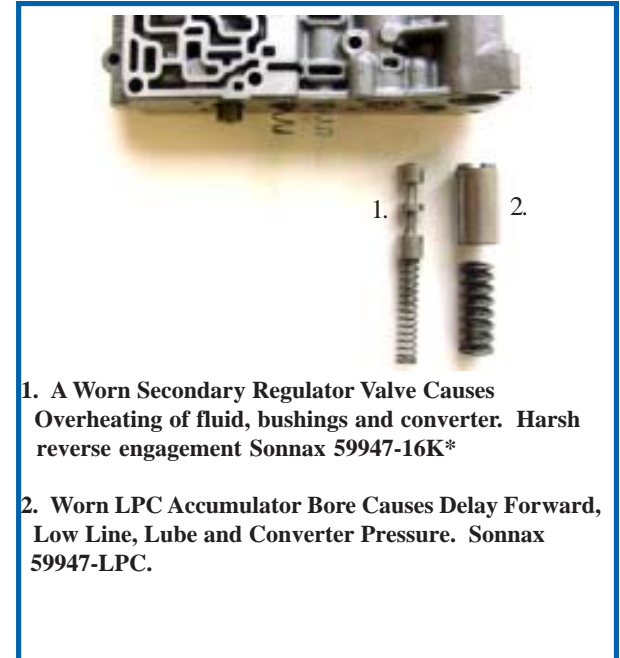
7.

- 1. A Worn Secondary Regulator Valve Causes Overheating of fluid, bushings and converter. Harsh reverse engagement Sonnax 59947-16K*
- 2. Worn LPC Accumulator Bore Causes Delay Forward, Low Line, Lube and Converter Pressure. Sonnax 59947-LPC.
