Total Car Care Technical Service Bulletins

Manufacturer: Nissan (TSB # 11-046a)

Subject: JUKE and VERSA: Checking for A/C Evaporator Leak

Model: 2011-2012 Juke - All
2007-2011 Versa Sedan - All
2007-2012 Versa Hatchback - Vehicles Built before on:
3N1BC1CP(*)CK 196927 /Aug 24,2011
3N1BC1CP(*)CL 364496 /Aug 30,2011

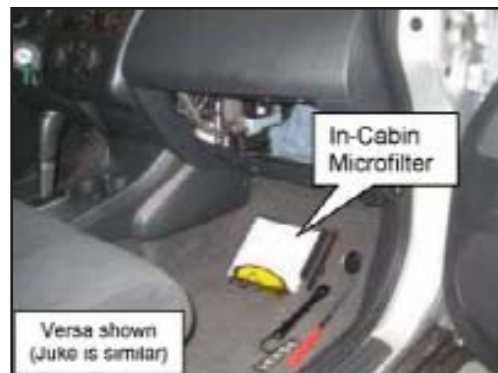
Figure 1

Check for refrigerant oil on the In-Cabin Microfilter.

- a. Remove the In-Cabin Microfilter
 - Refer to DirecTech PRO/ALLDATA as needed for filter removal.
- b. Refrigerant oil on the filter indicates the evaporator is leaking..

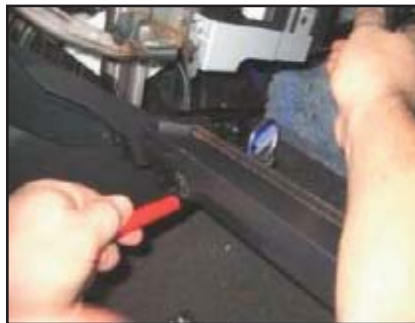
Figure 2

Check for oil/dye on evaporator tubes or surface.

- a. Remove the glove box.
 - Refer to DirecTechPRO/ALLDATA as needed for glove box removal information.
- b. Use a mirror, ultraviolet light and yellow glasses to check for oil/dye on the evaporator surface/tubes.

NOTE Essential tool J-44926 (A/C Dye Leak Detection Kit) contains an ultraviolet light and yellow glasses. Equivalent light and glasses can also be used.

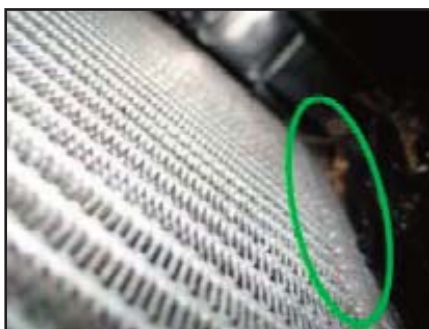
Figure 3

·If oil is on the evaporator, it is usually on the lower tank.

·Refrigerant oil/dye visible on the evaporator indicates the evaporator is leaking.

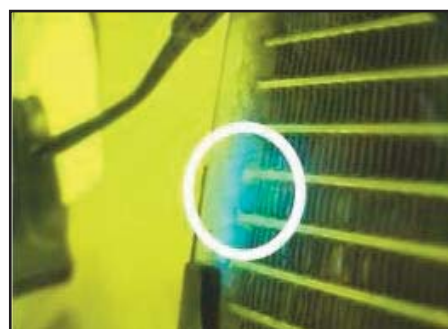
Figure 4

Example of evaporator leak:

·Oil/dye is present where tubes attach to the lower tank.
