Do These or CB's

Enclosed is a General List of tests, checks and basic things you should do as part of an EDS, Rebuilding, Inspection of a transmission or installing a fresh rebuild. Read them over, become familiar with them, if you're not already, and put them into practice.

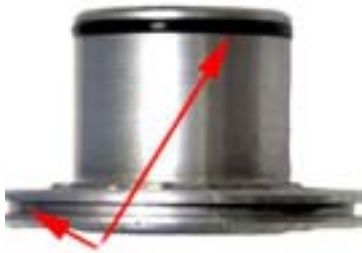
7.

Always use the updated 1-2 accumulator with rubber seals. GM # 8680929

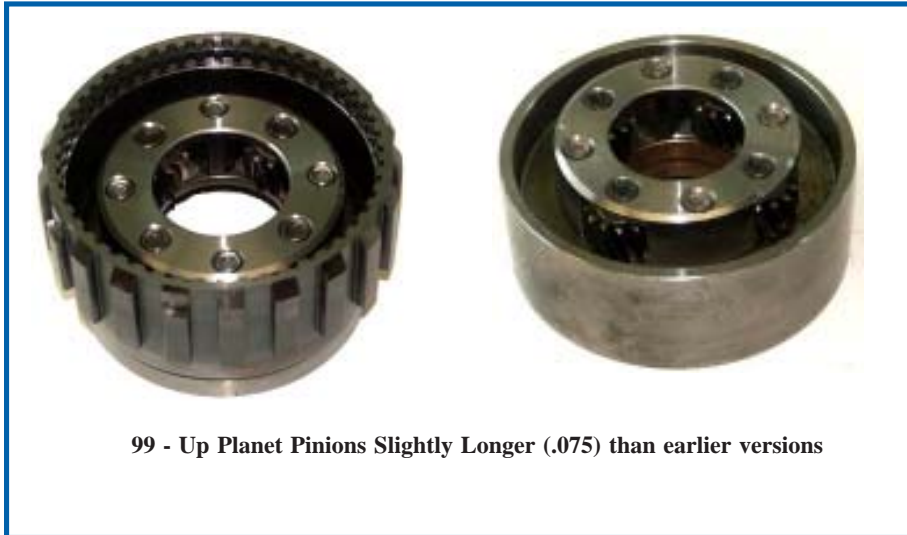
13.

99 - Up Planet Pinions Slightly Longer (.075) than earlier versions

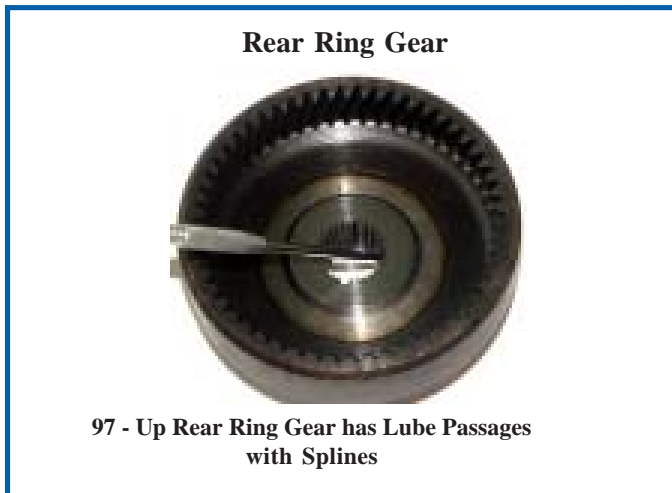
15.

Rear Ring Gear

97 - Up Rear Ring Gear has Lube Passages with Splines

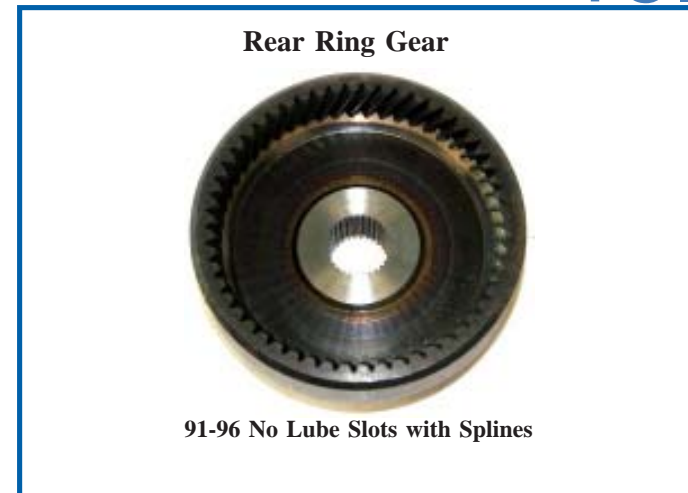
16.

Rear Ring Gear

91-96 No Lube Slots with Splines

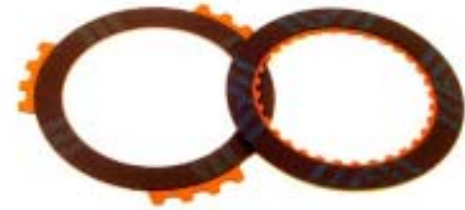
6.

One sided frictions - start with external spline with friction material up and alternate with internal spline plates.

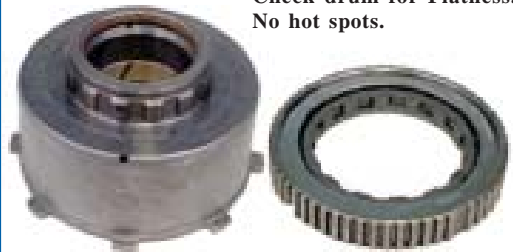
7.

Check drum for Flatness.
No hot spots.

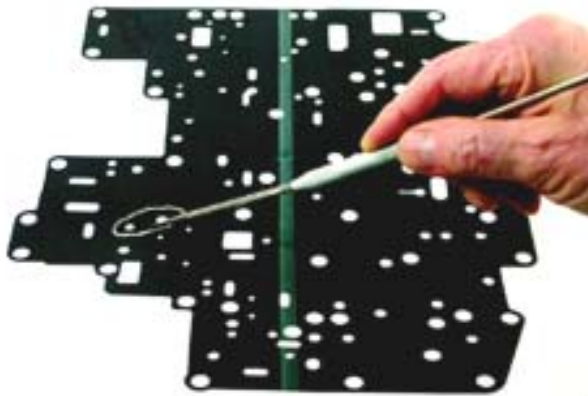
92 - 94 No slot between these holes

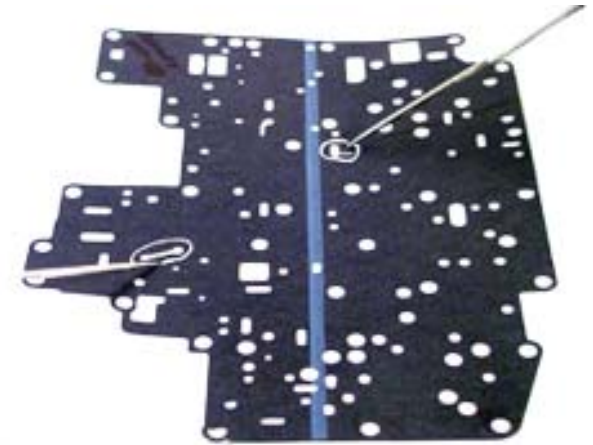
01 - Up Has slot between holes and slot added to hole shown

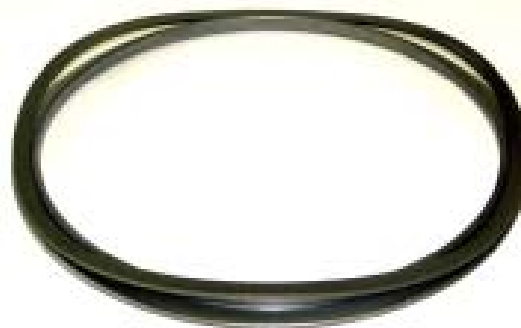
Units with a bonded intermediate clutch piston use an L shaped retainer and cushion spring on top of the top steel clutch plate.

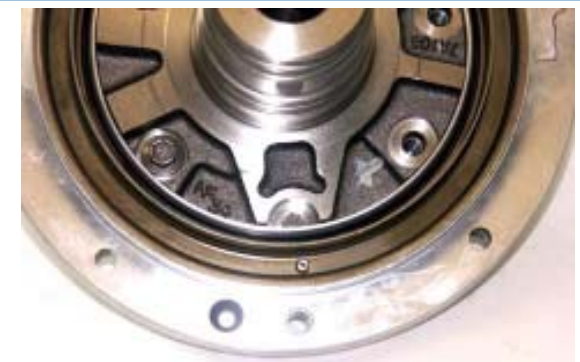
Always line up intermediate clutch piston checkball capsule to the pump cover as shown.

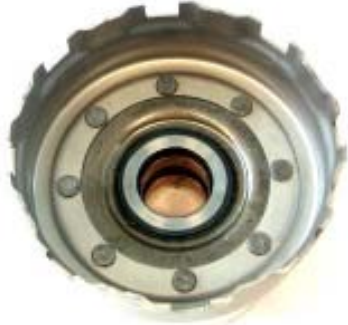
7.

2004 Up units with a turbine speed sensor use a non ferrous (Non magnetic) sun gear shell. Some shells are easily identified by being revited together although there are shells that are not. Bottom line is if you use a ferrous metal shell the turbine sensor will not read - use the correct parts

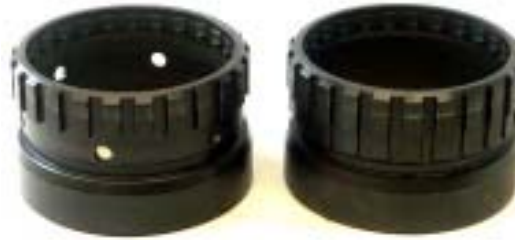
8.

1992-2003

2004-Up

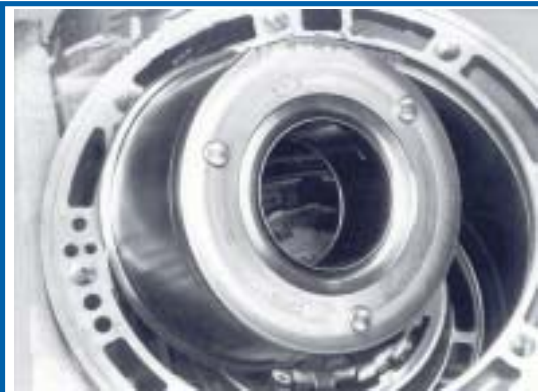
1.

Always remove the sensor ring from the overdrive clutch drum, it's not needed.

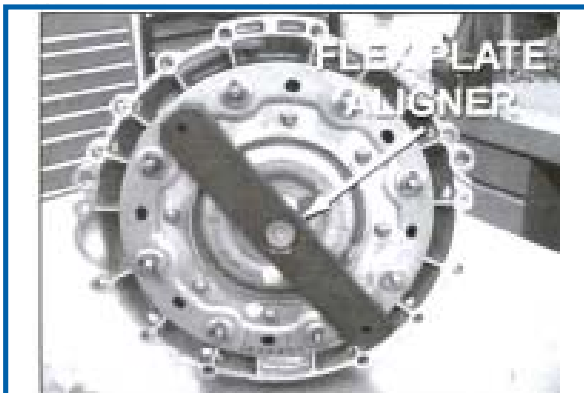
11.

If equipped-use the flex plate aligner 307-403 (or equivalent) to install the torque converter flex plate adapter and nuts.

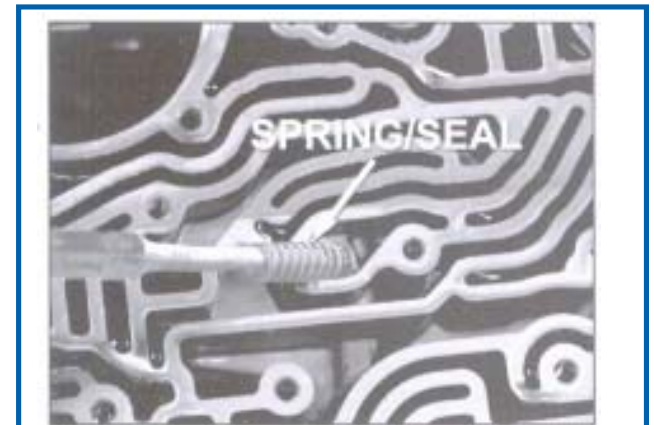
12.

5R55N make sure intermediate clutch inlet tube seal is seated correctly. Must Fit in hole in Case

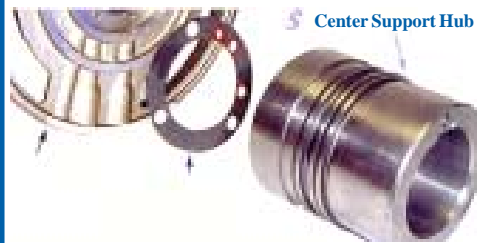
8.

Prevent burnt forward and direct clutches.

Always install a gasket it prevents leaks use Sonnax # 367743G

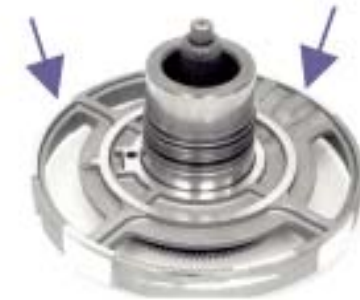
9.

Look for wear Here and in the Case. Worn Case will wear out New Supports without modification below.

Remove support tower. Machine outer edge of support down .050 inch. Place a .050" ATX Reverse Case snap-ring into case 1st. Install modified support just like a 400 transmission.

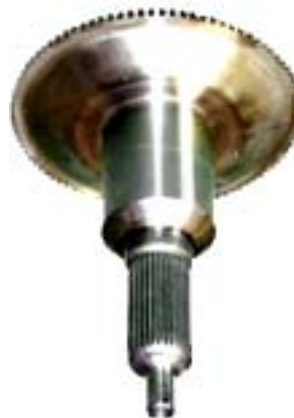
11.

Install a bronze GM ext. housing bushing into hub.

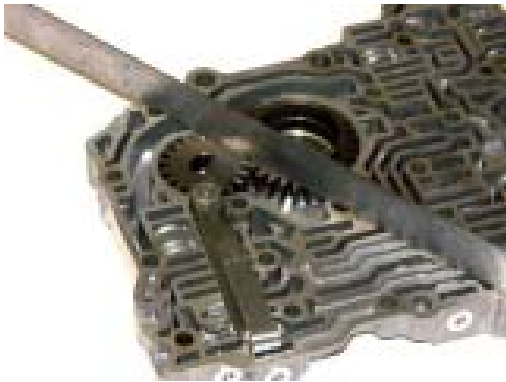
1.

Always Check Pump Clearance .003 Max.

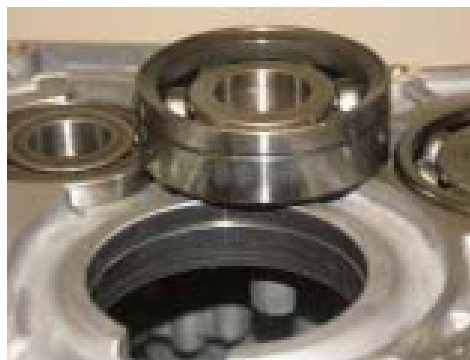
5.

Check case for bearings spinning. Common Problem.

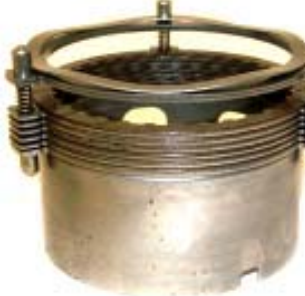
1.

Top 1 or 2 Steel Plates are selective

.118 Thick Plate on Bottom

Improperly stacked B2 clutch can = slips 1-2 and/or 3-4. Binds in reverse and manual low.

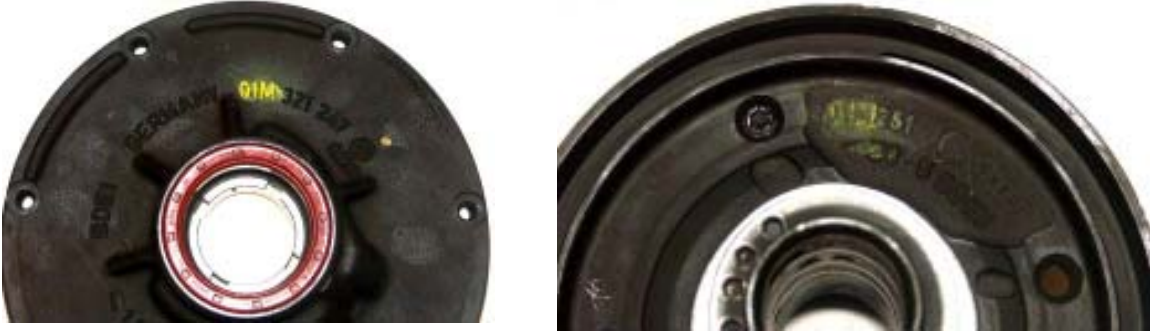
4.

If you are replacing pump or stator make sure you have the correct parts - O1M or Phase 2 units will have O1M cast in the pump body and pump cover. 096 or Phase 0 & 1 units will have 095

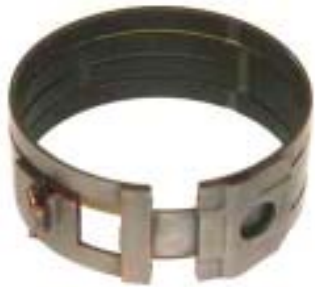
1.

Use OE replacement band whenever possible.
Nicer 2-3 shift.

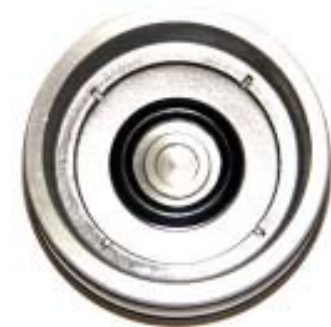
4.

On Volvo units if your servo cover looks like this, update to snap ring style, Volvo #
30751262
